The Maltings, Twelve Trees Crescent, London, E3 3TB

Report on Remedial Cladding Works

Report on Replacement Floor Recessed Lighting to Entrance of Block B

WATER INGRESS 194 MALTINGS CLOSE, LONDON E3 3TB

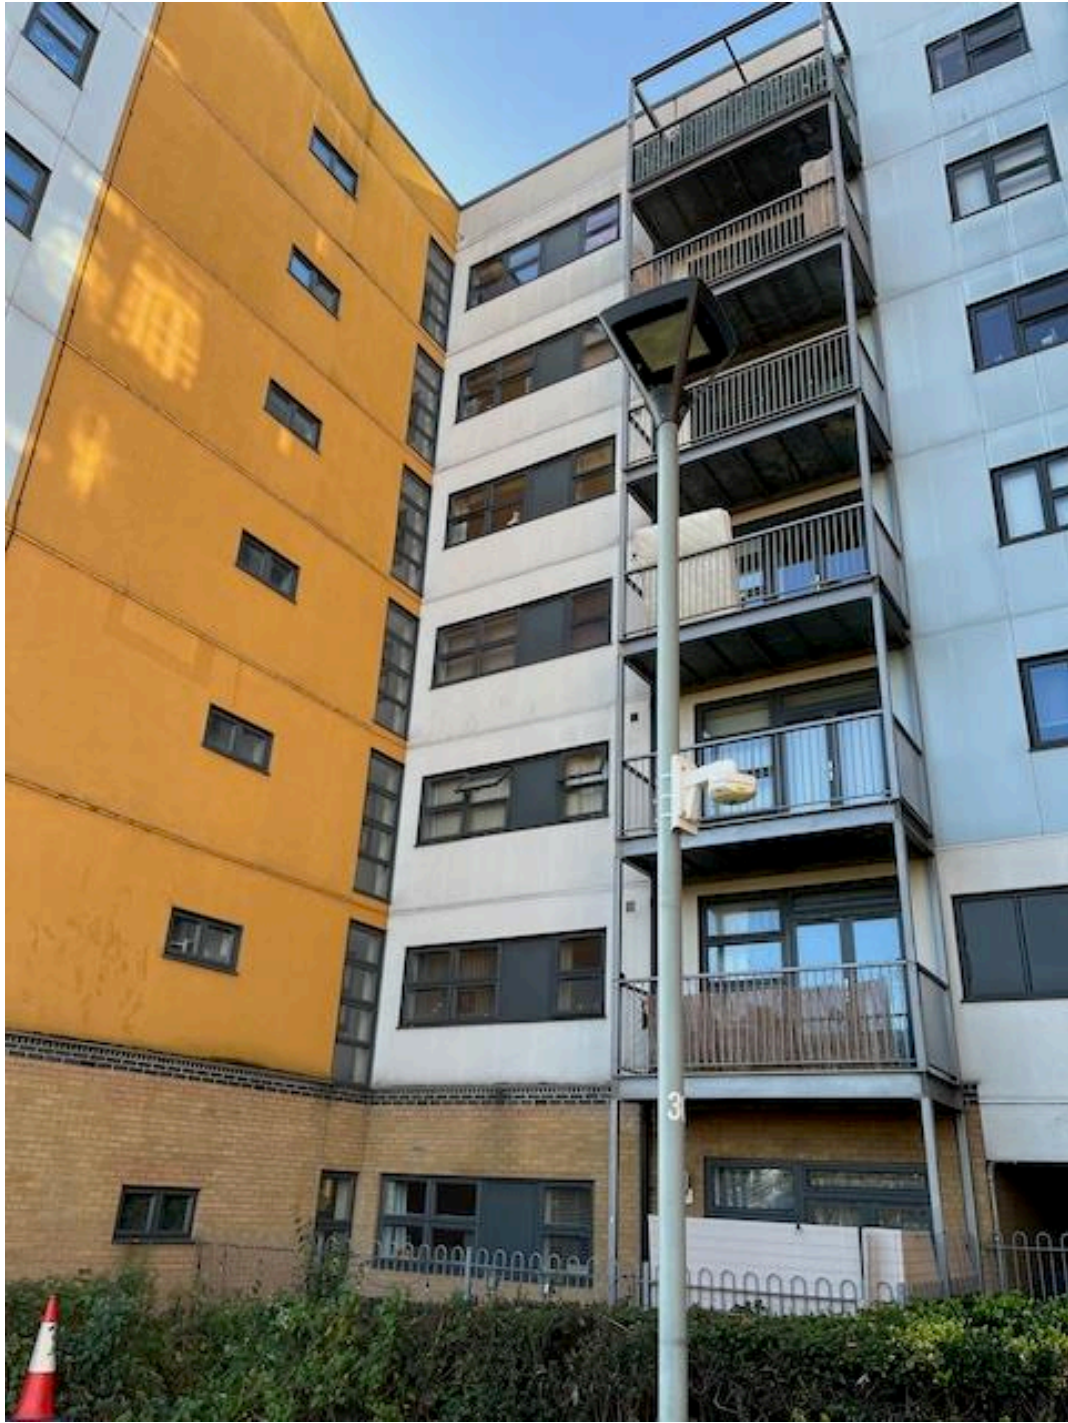
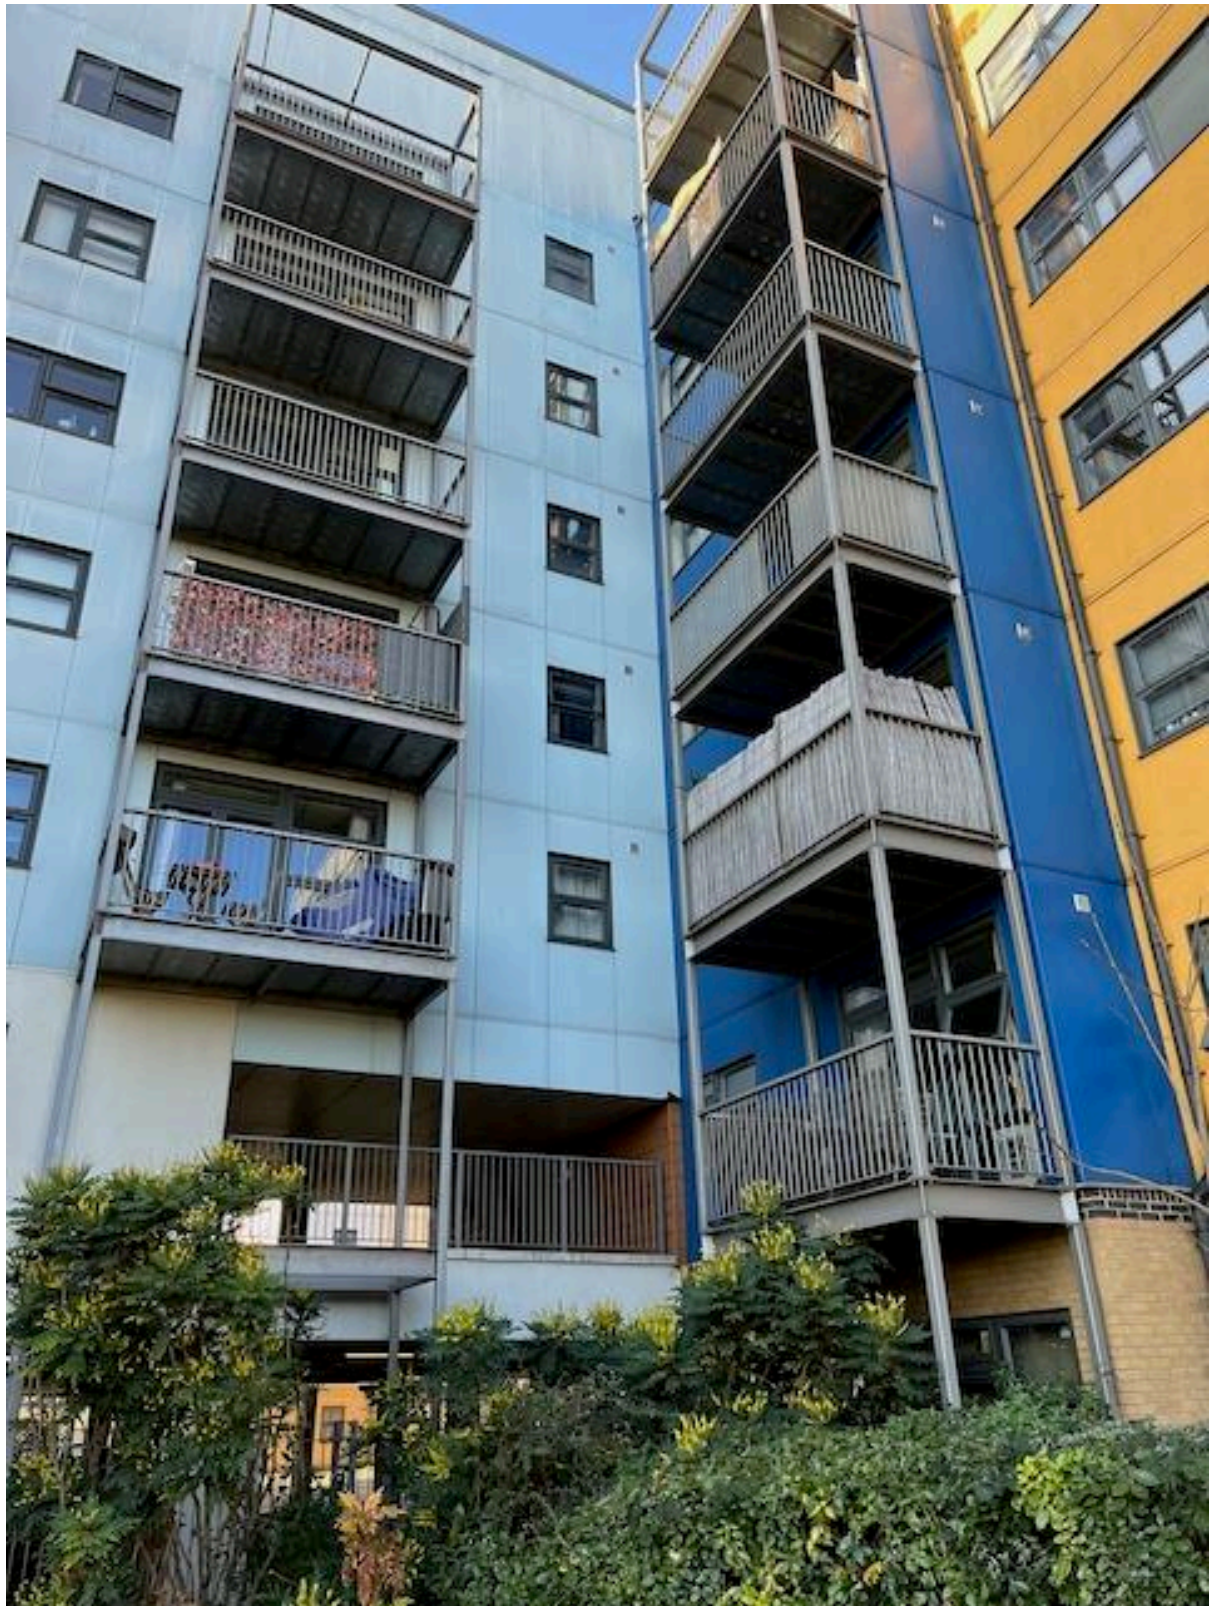
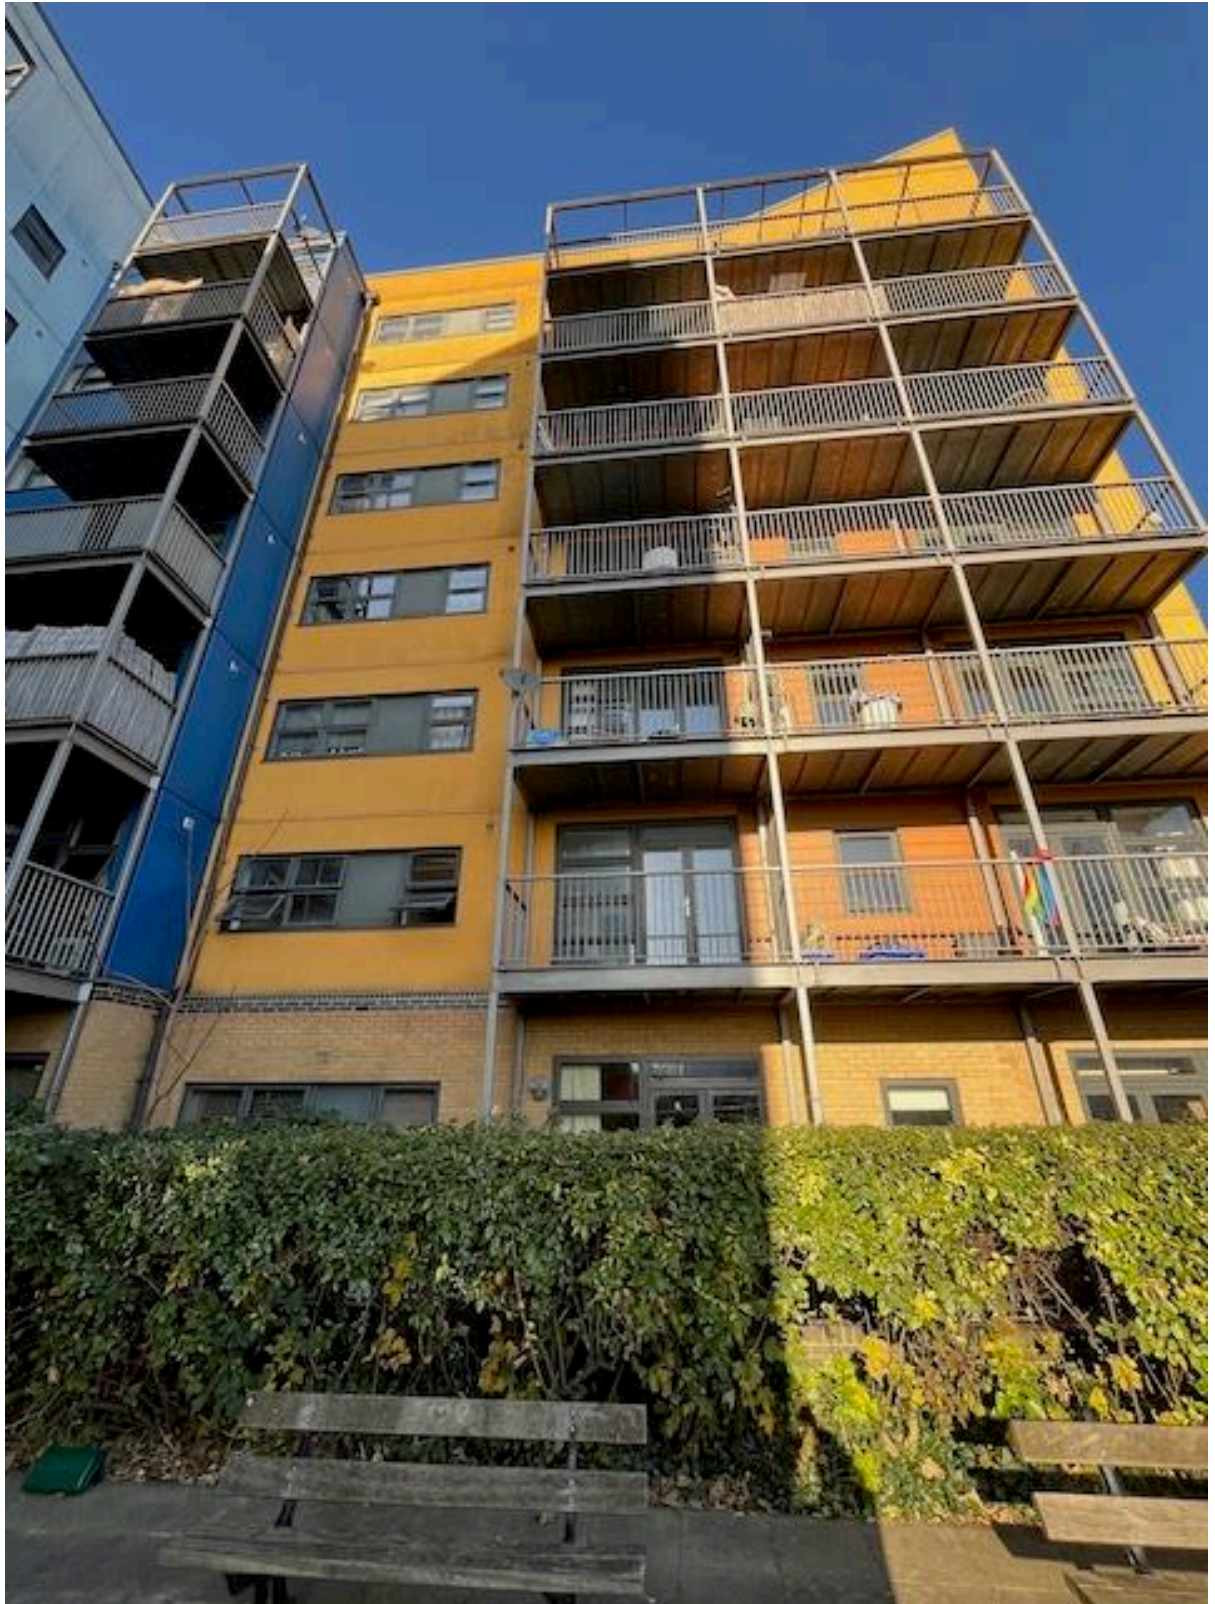
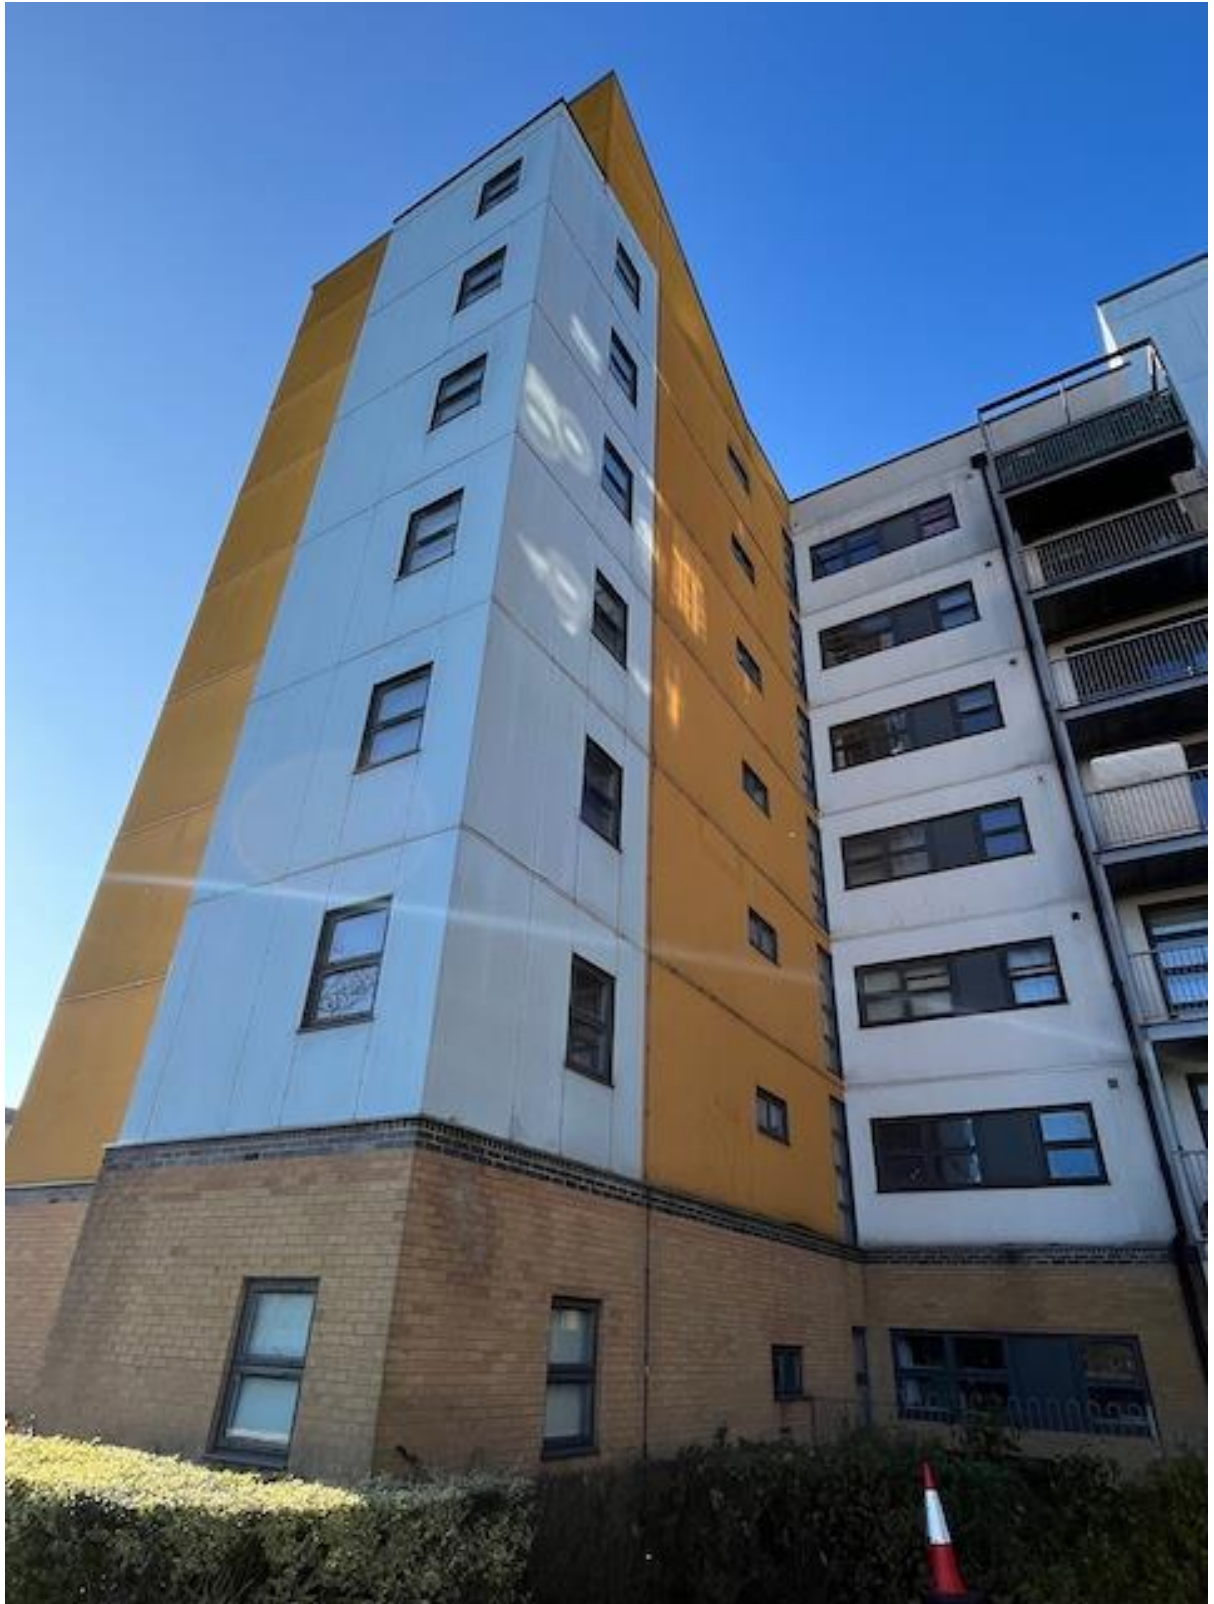
1. The west elevation is a mix of render and a panel system with exposed fixings above ground floor. The ground floor is clad in brick. There are steel balconies which apparently do not take support from the walls.

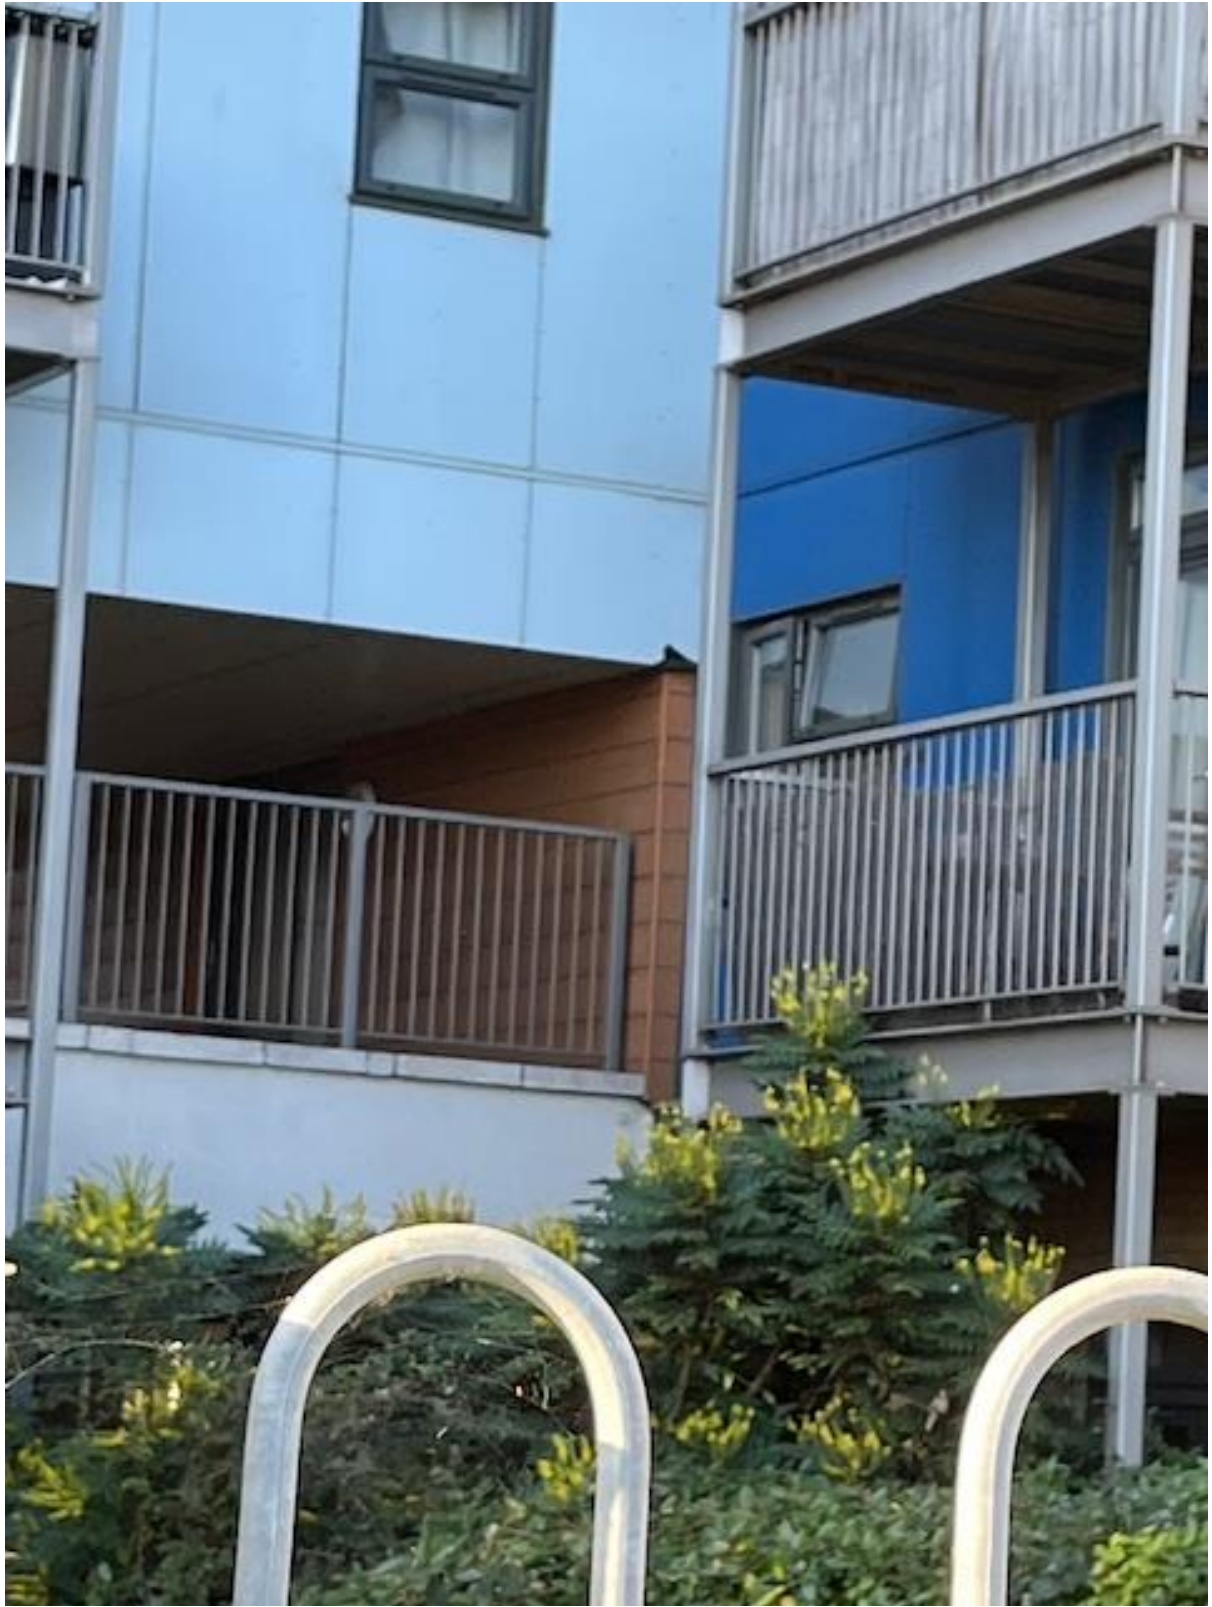
2. West elevation, base of third floor. Section of panel missing probably as a result of damage. It is not clear what is caused this but the construction behind is open to the elements

The external elevations of the building have deteriorated and been damaged over time and we would recommend that the render and panelled cladding be removed and the board under replaced with a non-combustible equivalent and cavity fire barriers put in place.

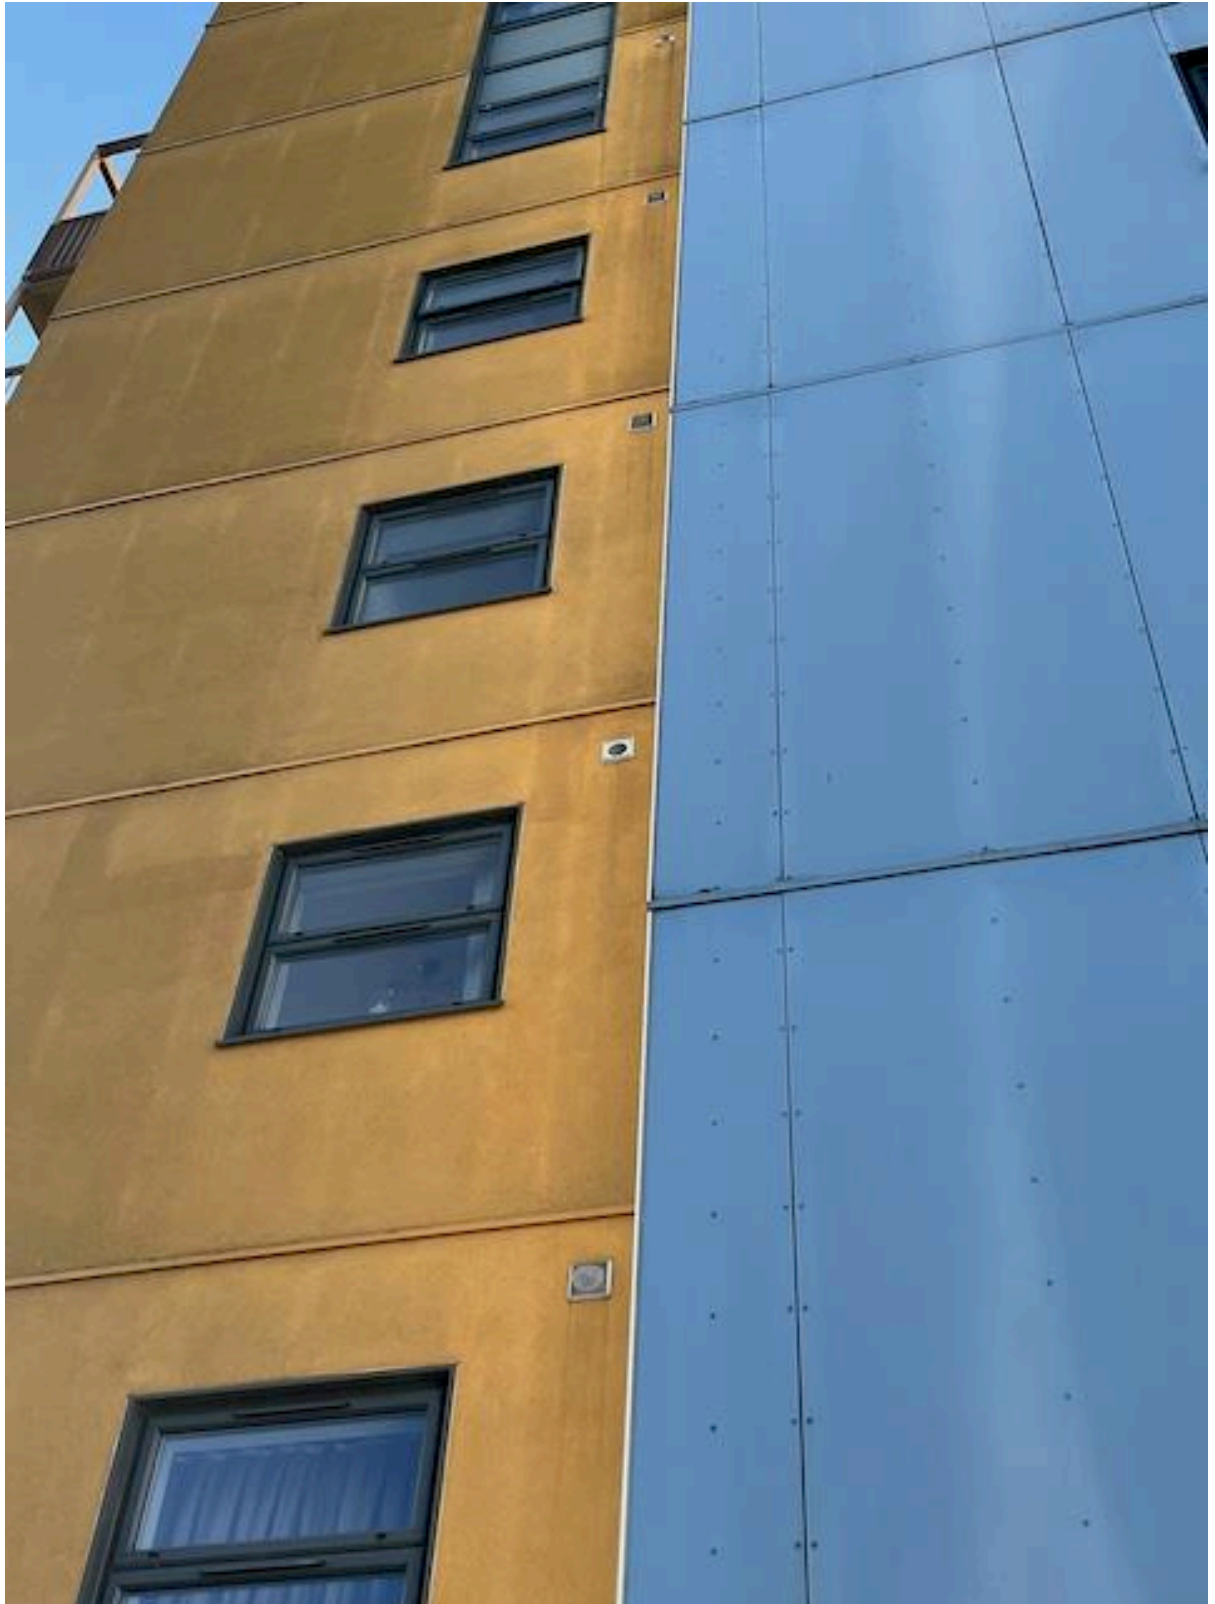
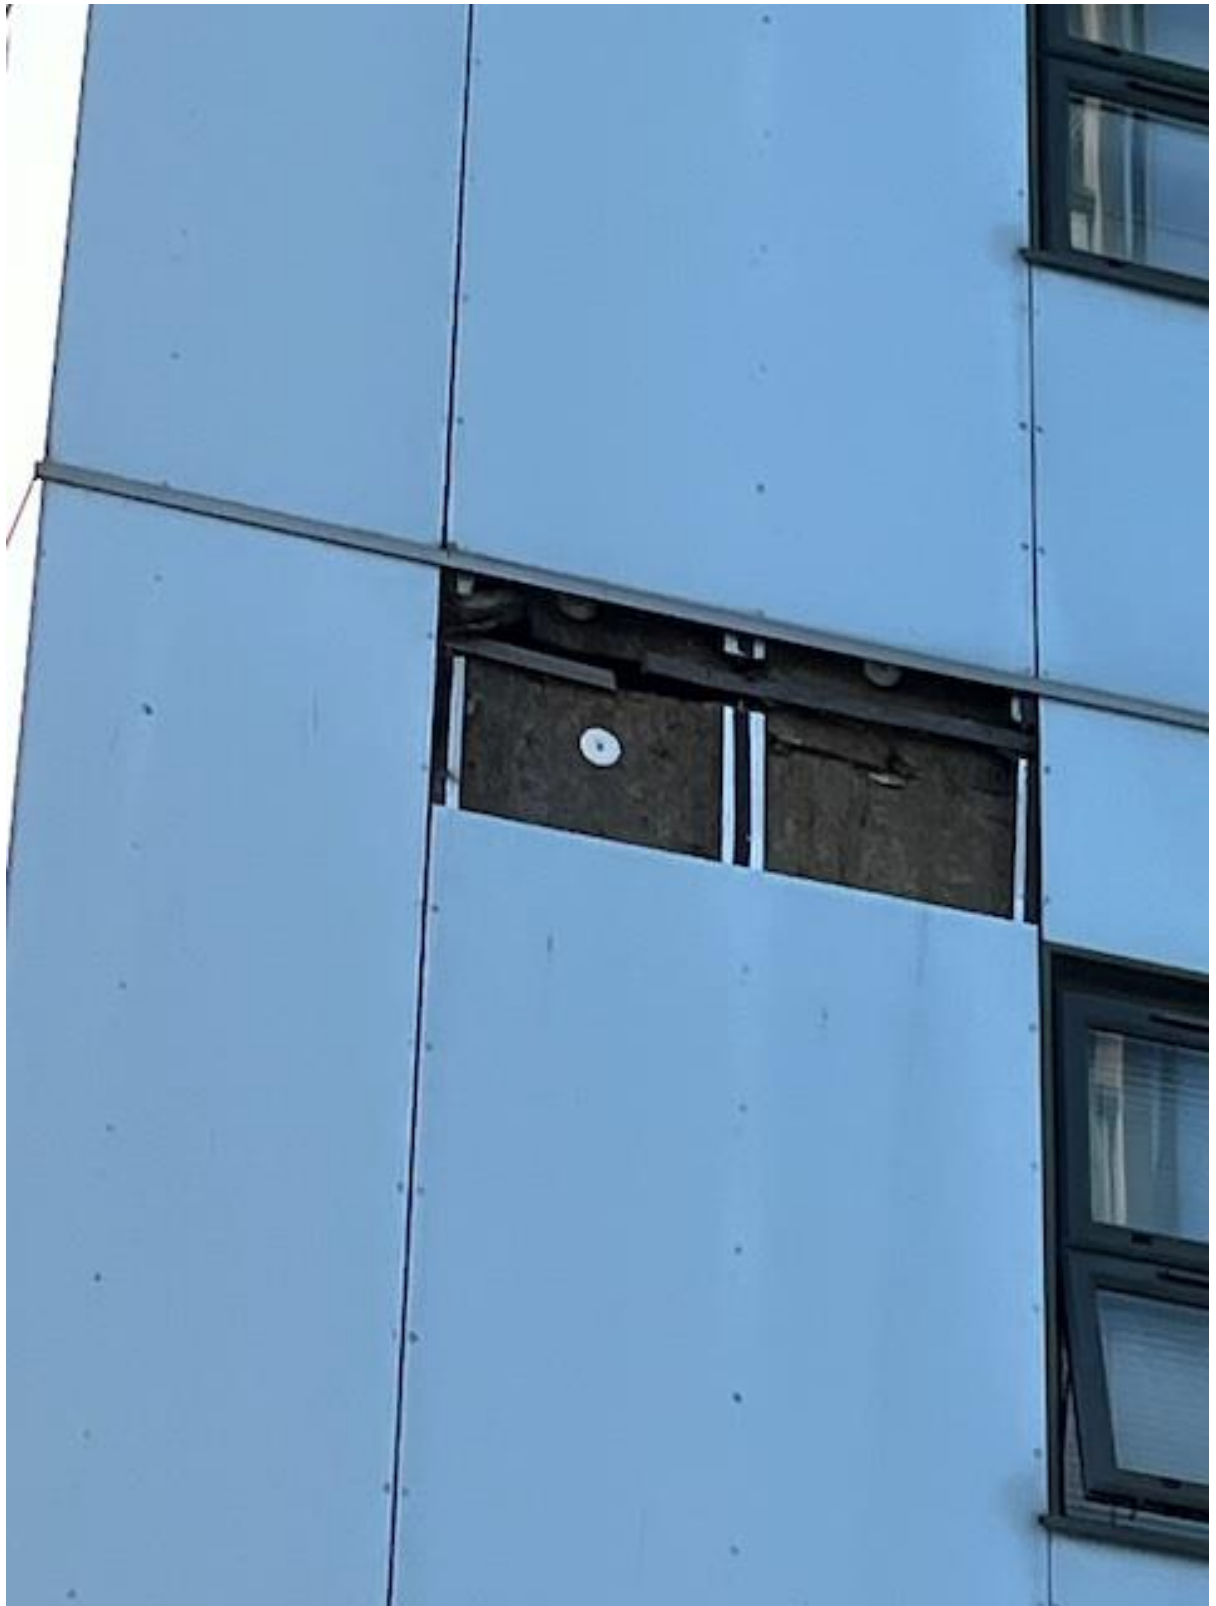
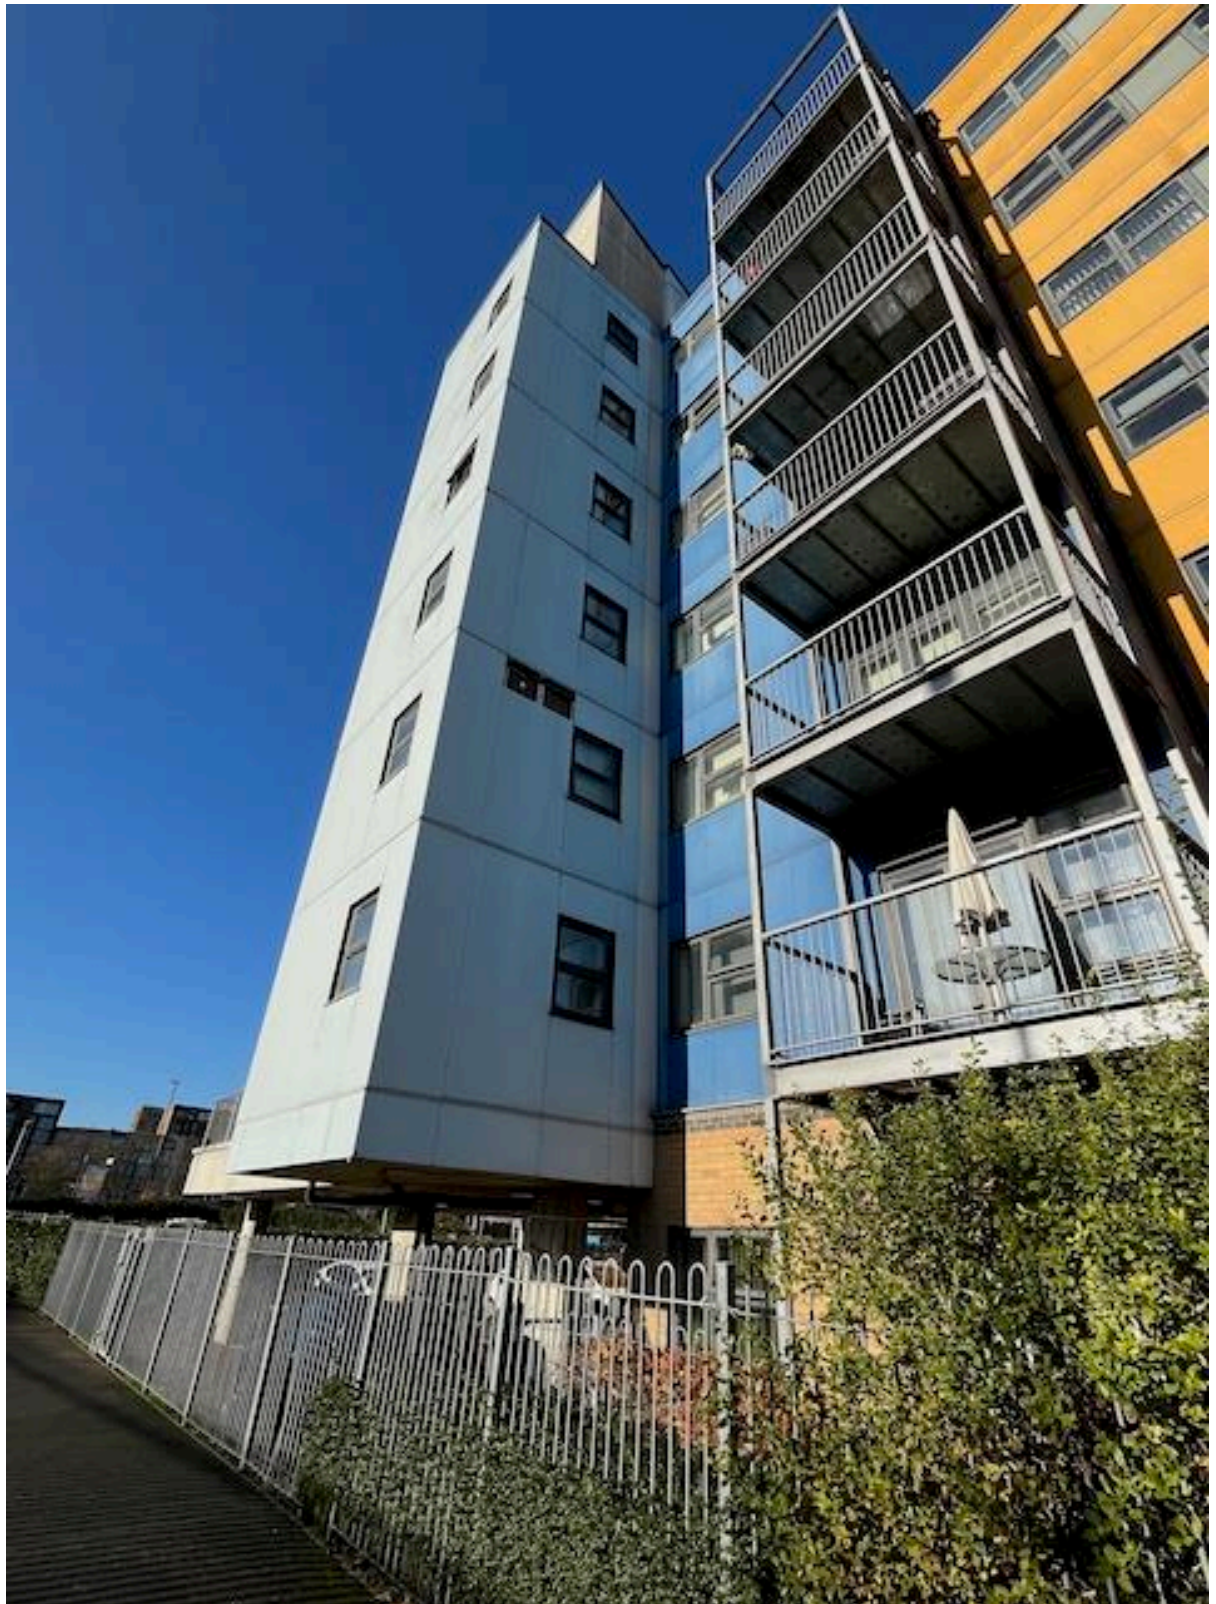
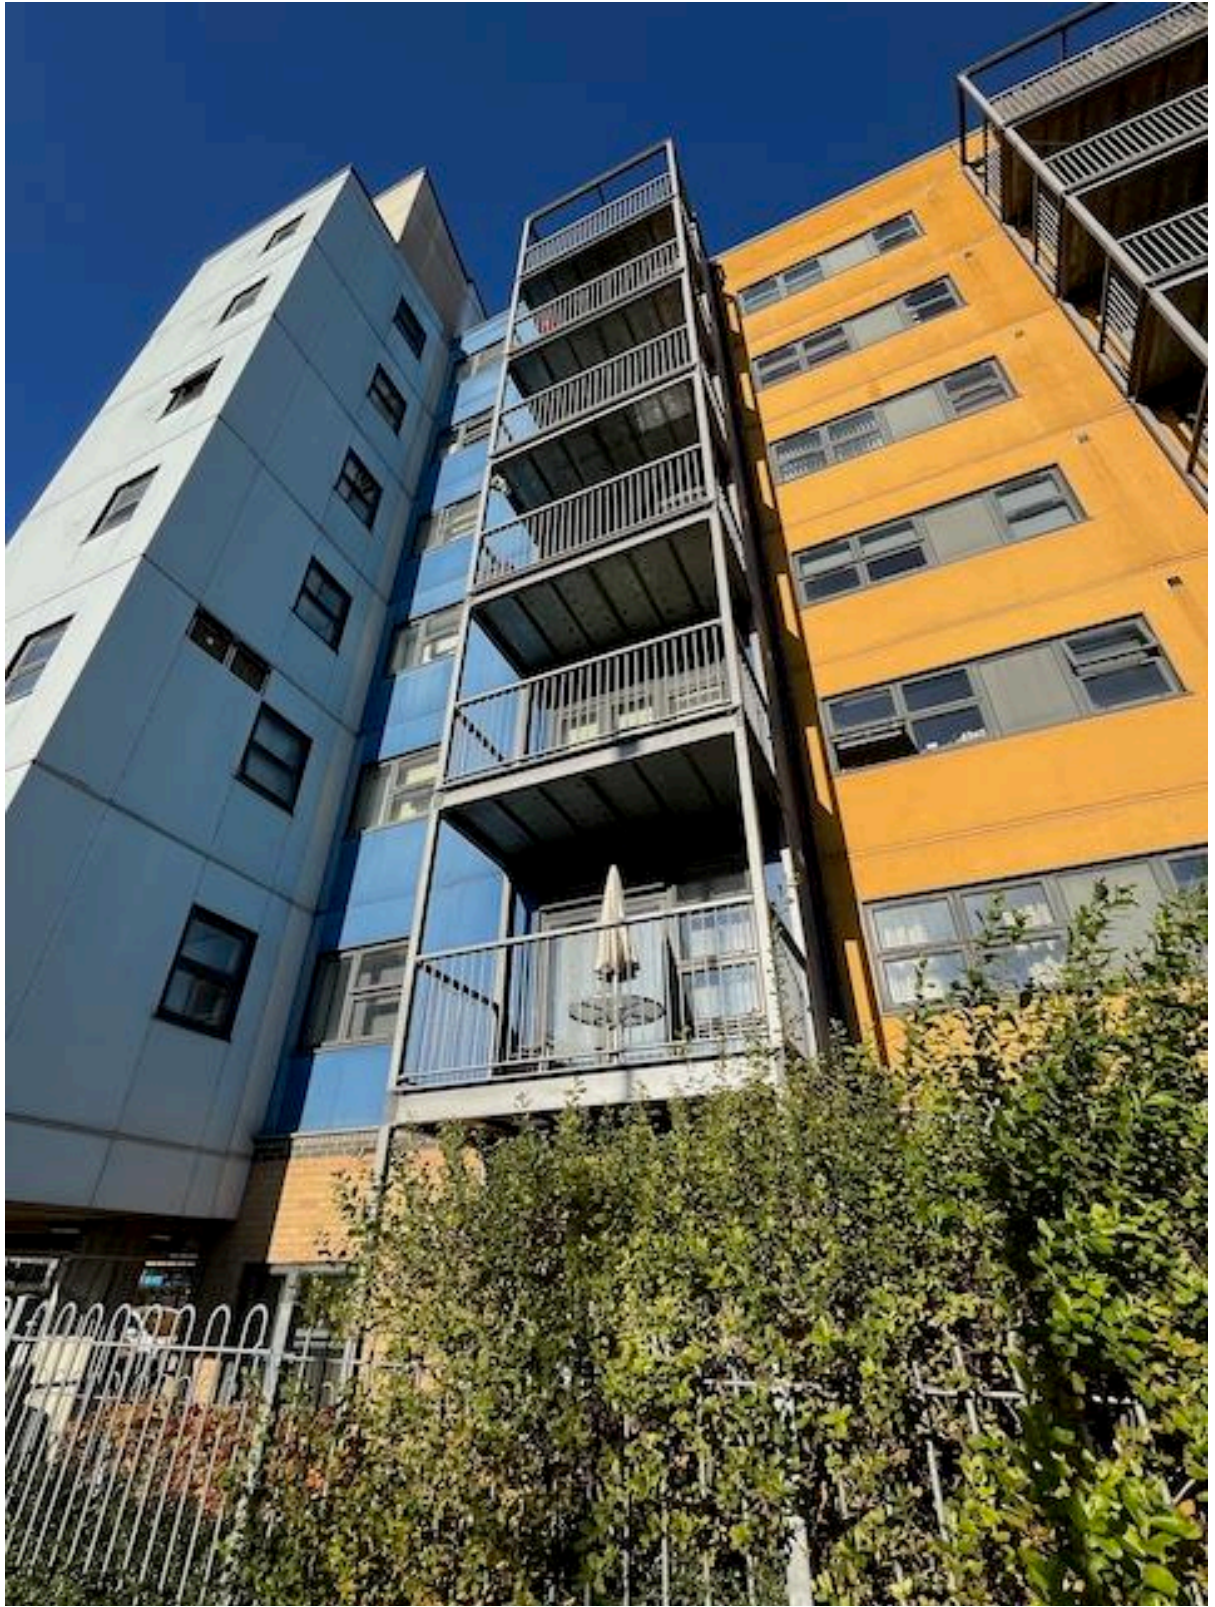
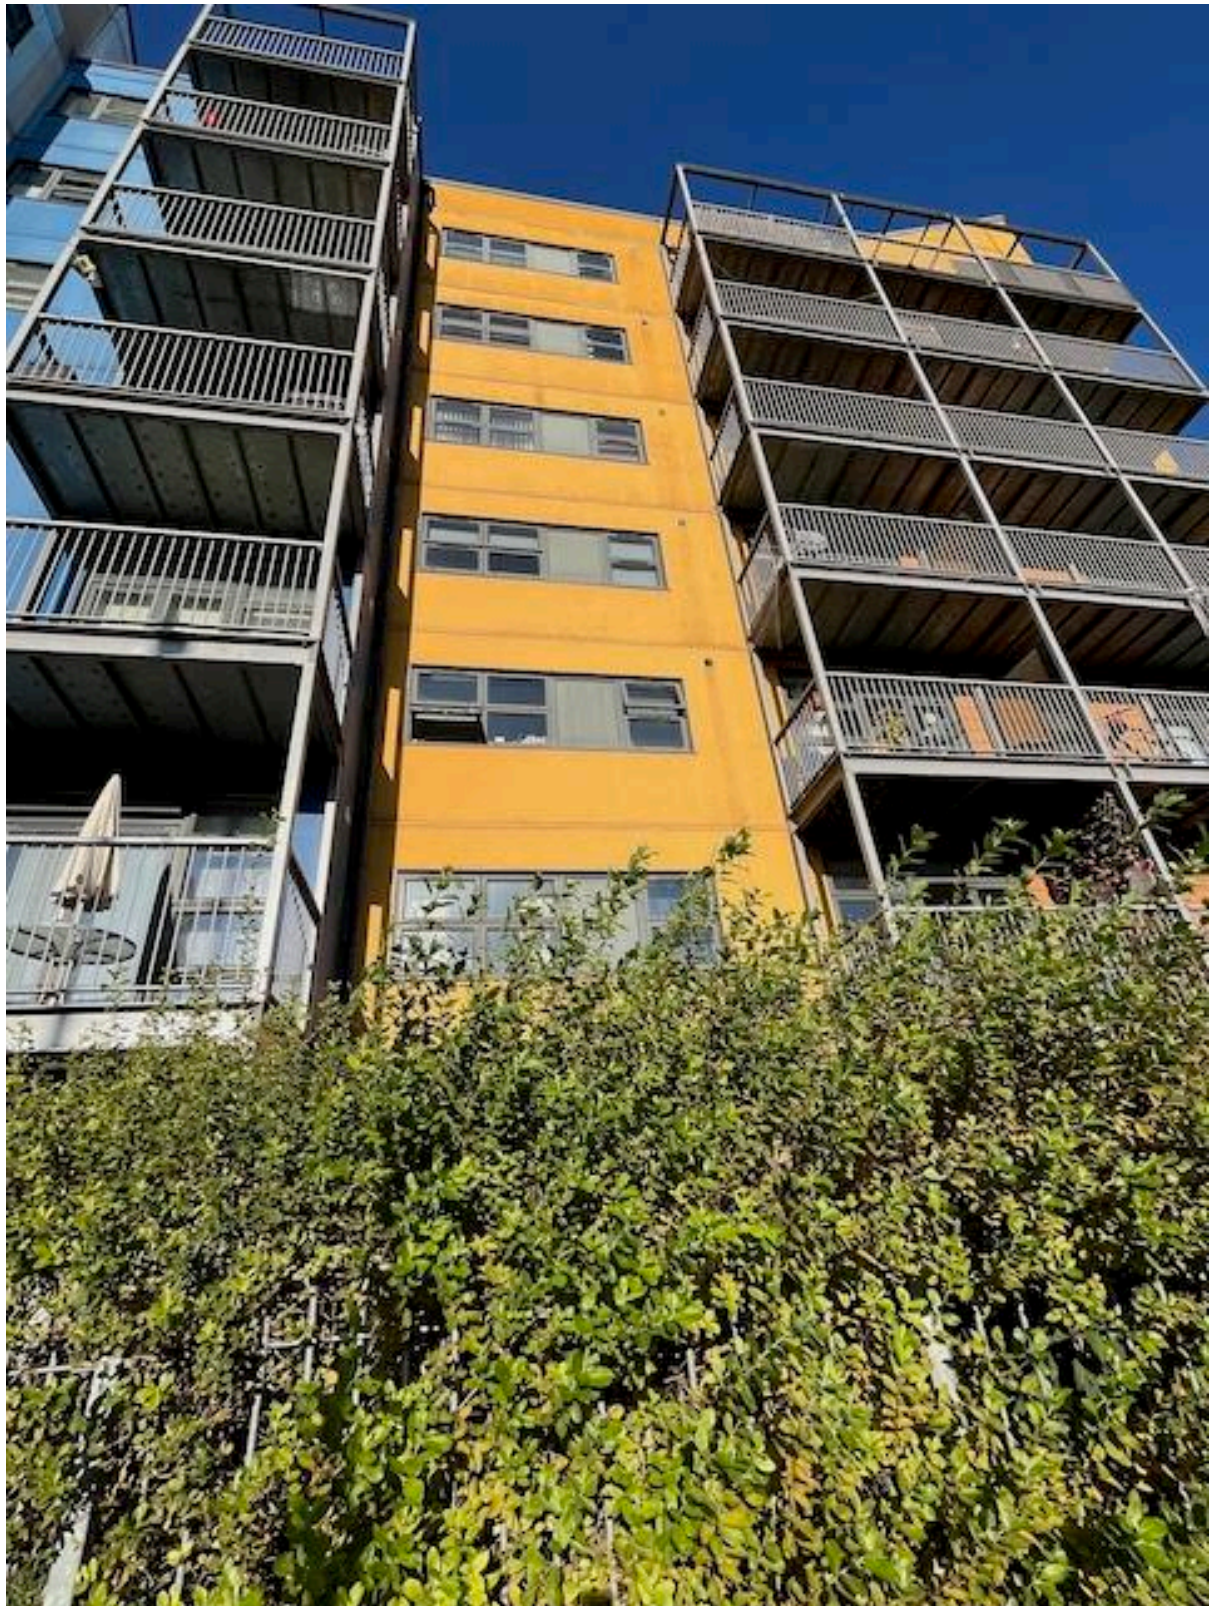
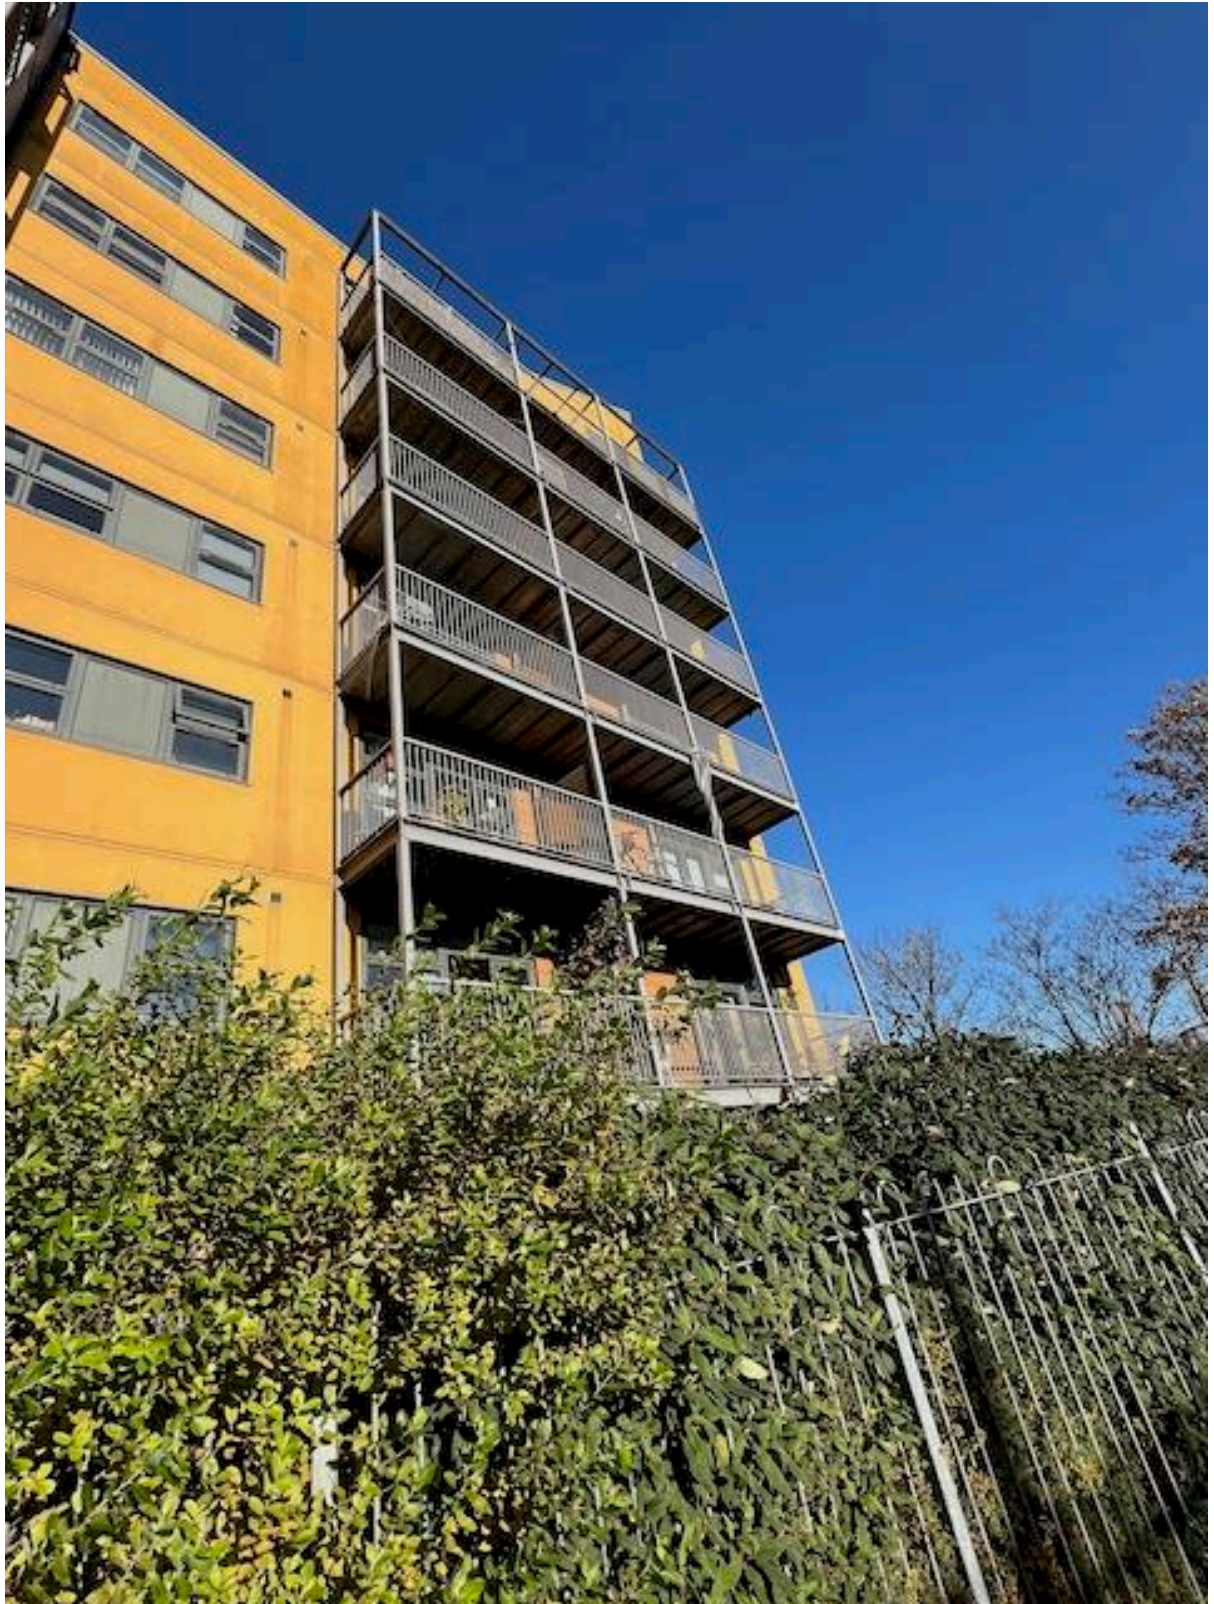
3. The panel system is showing age related decay with horizontal joints standing slightly proud of panels and panels coming loose. The render is discoloured but is in satisfactory condition except for horizontal joints which are again showing deterioration.
4. South elevation. On south-west corner a panel is missing on the second floor. The construction that is showing behind appears to be metal framing with either a board or Rockwool batts between. There is horizontal timber member with gaps in the board/Rockwool.
