The Maltings, Twelve Trees Crescent, London, E3 3TB

Report on Remedial Cladding Works

Report on Replacement Floor Recessed Lighting to Entrance of Block B

WATER INGRESS 194 MALTINGS CLOSE, LONDON E3 3TB

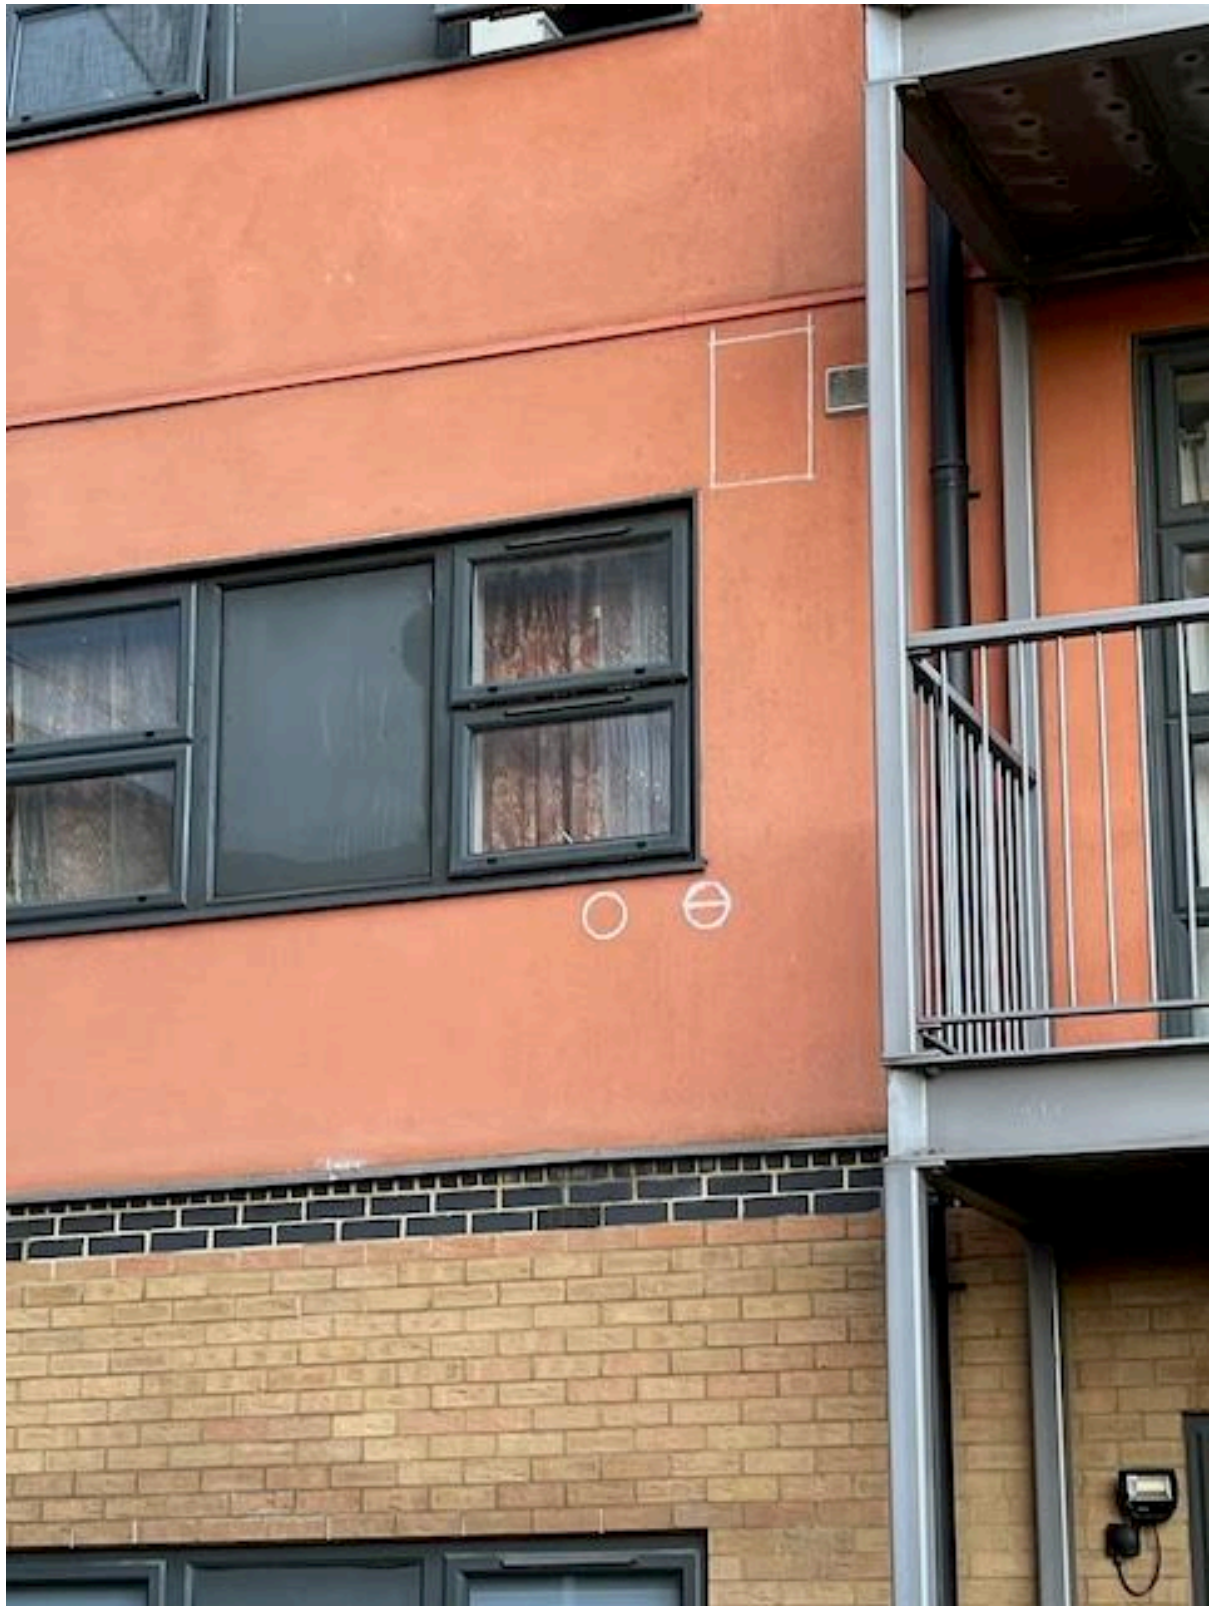
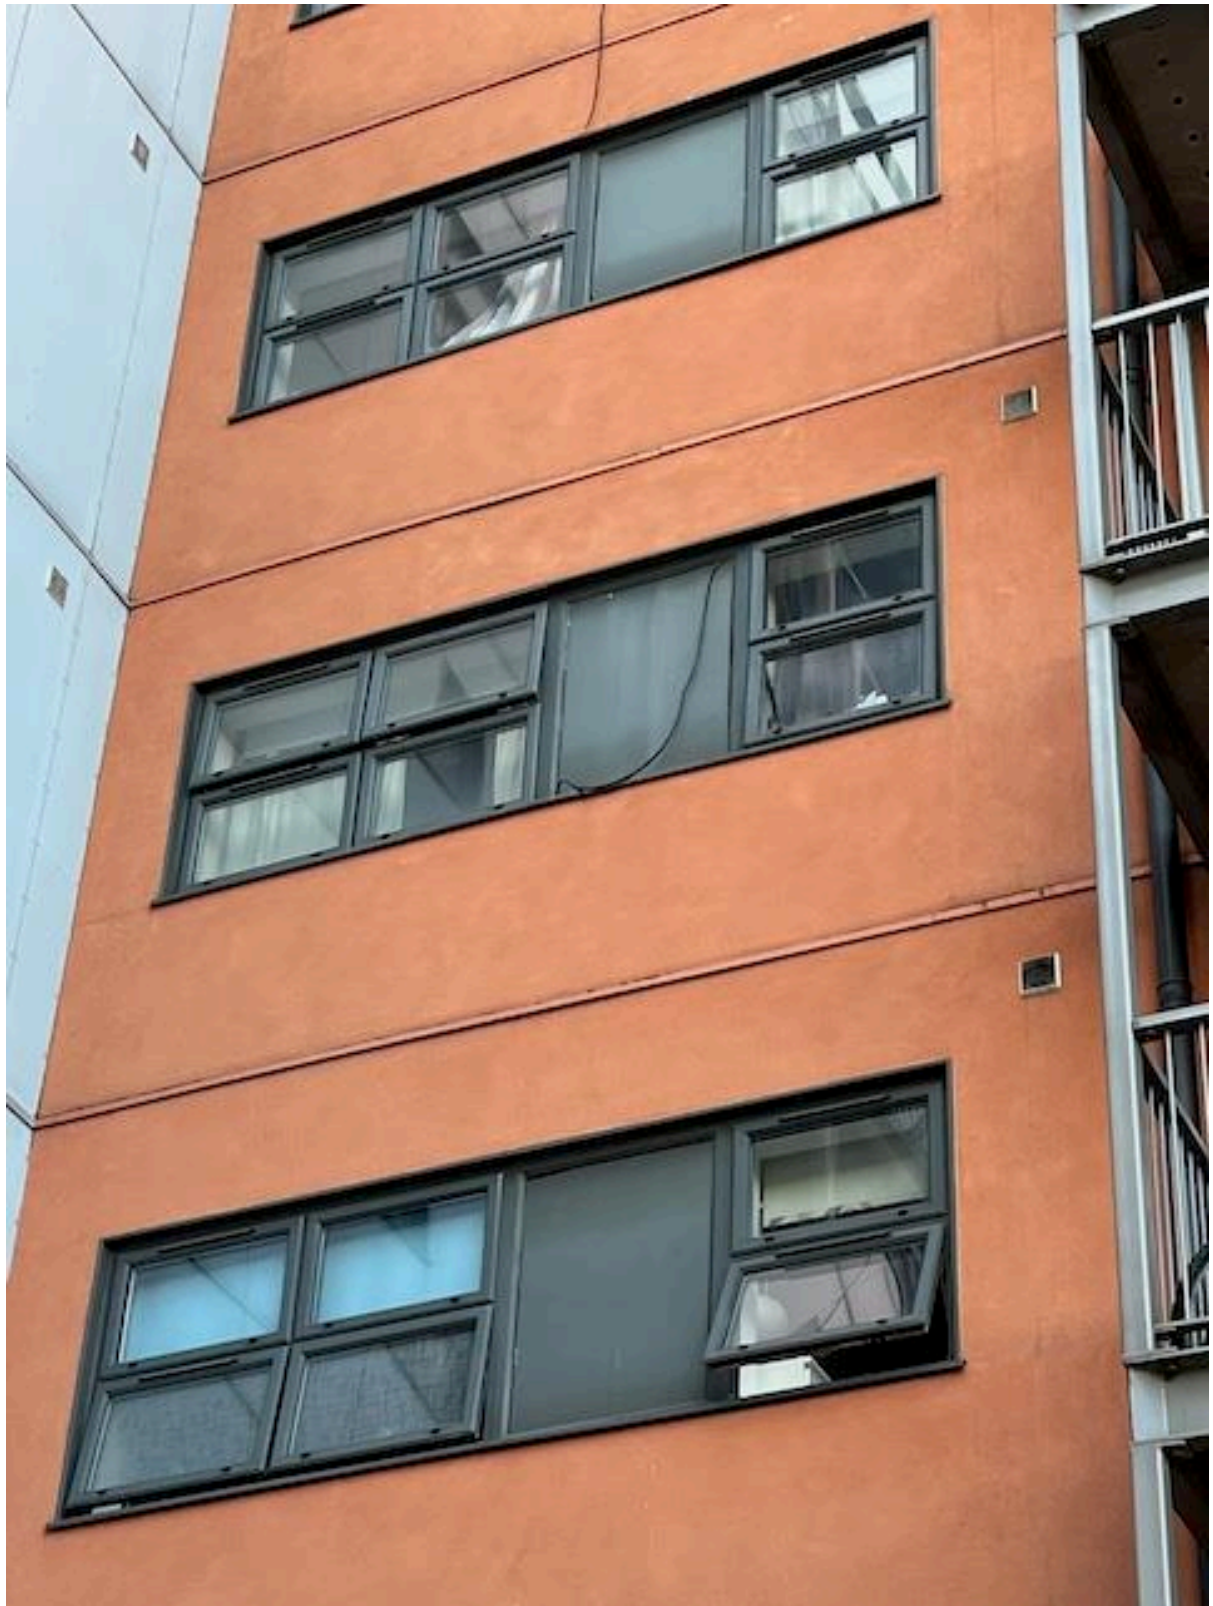
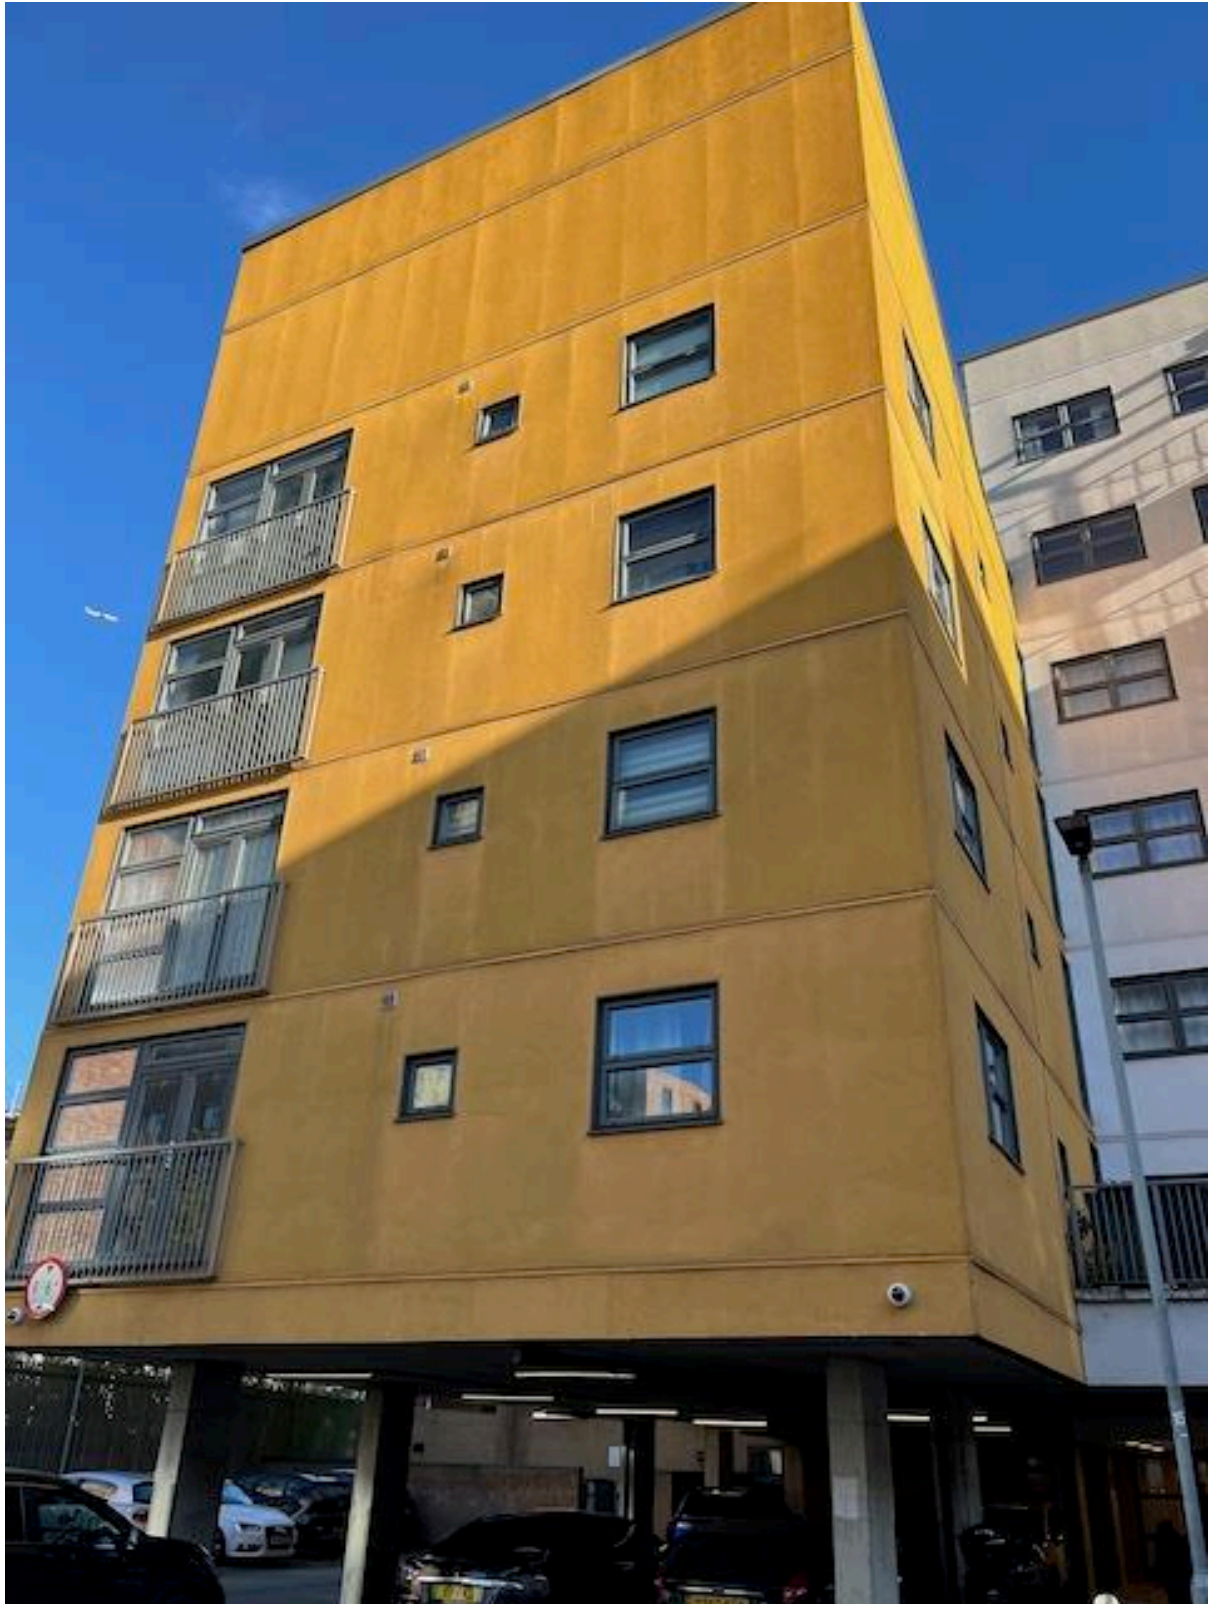
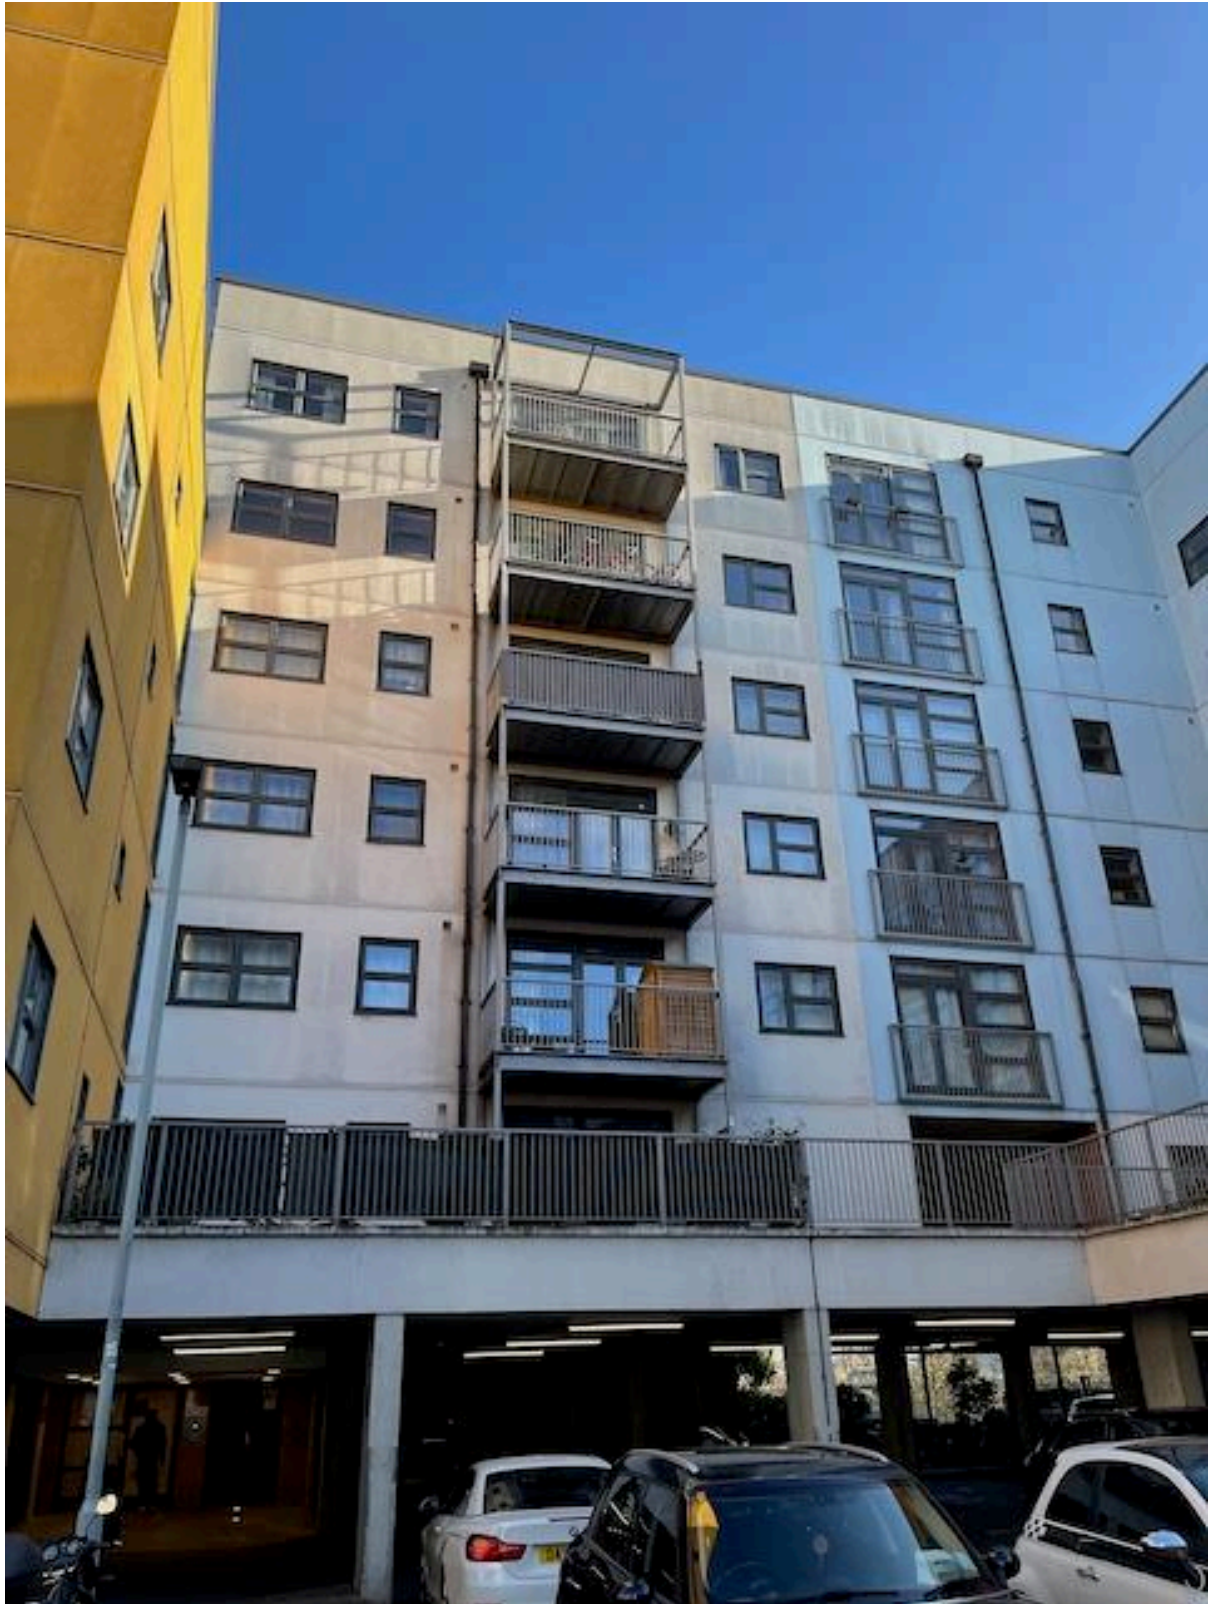
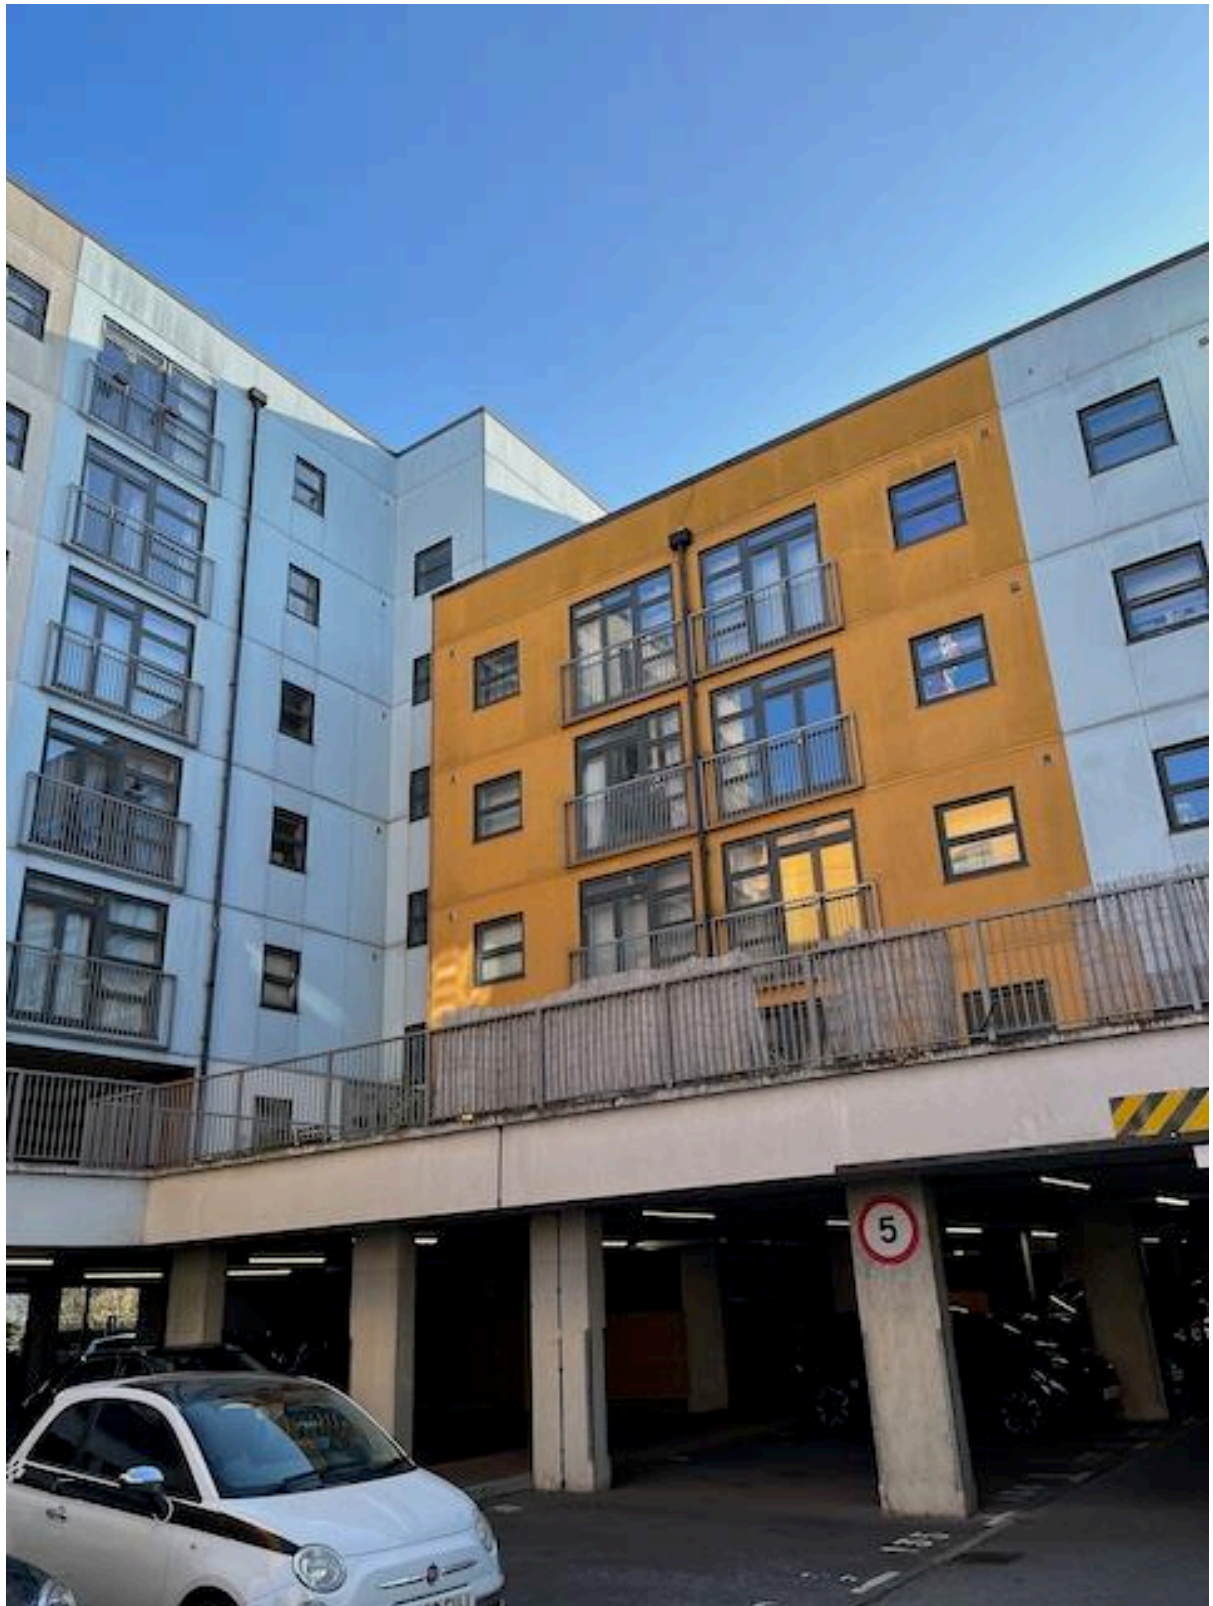
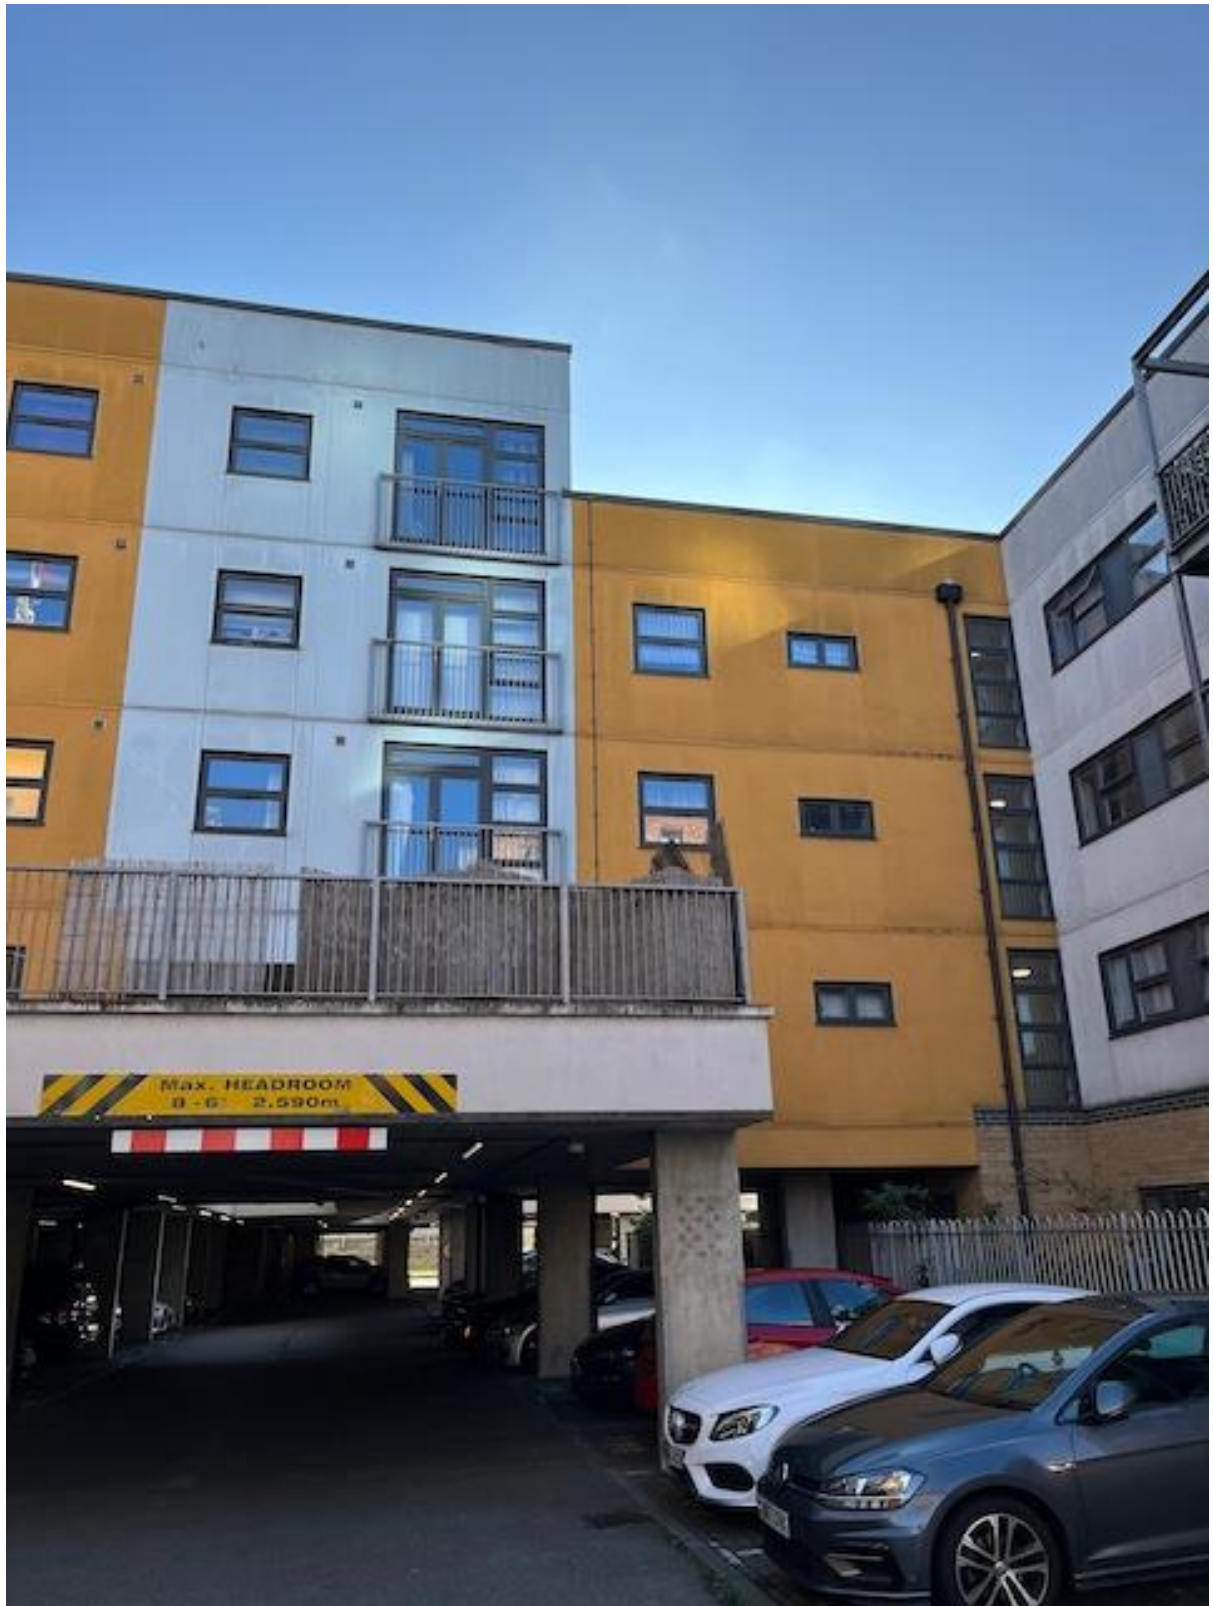
5. North and East elevations. No obvious damage is present but the cladding shows age related deterioration.

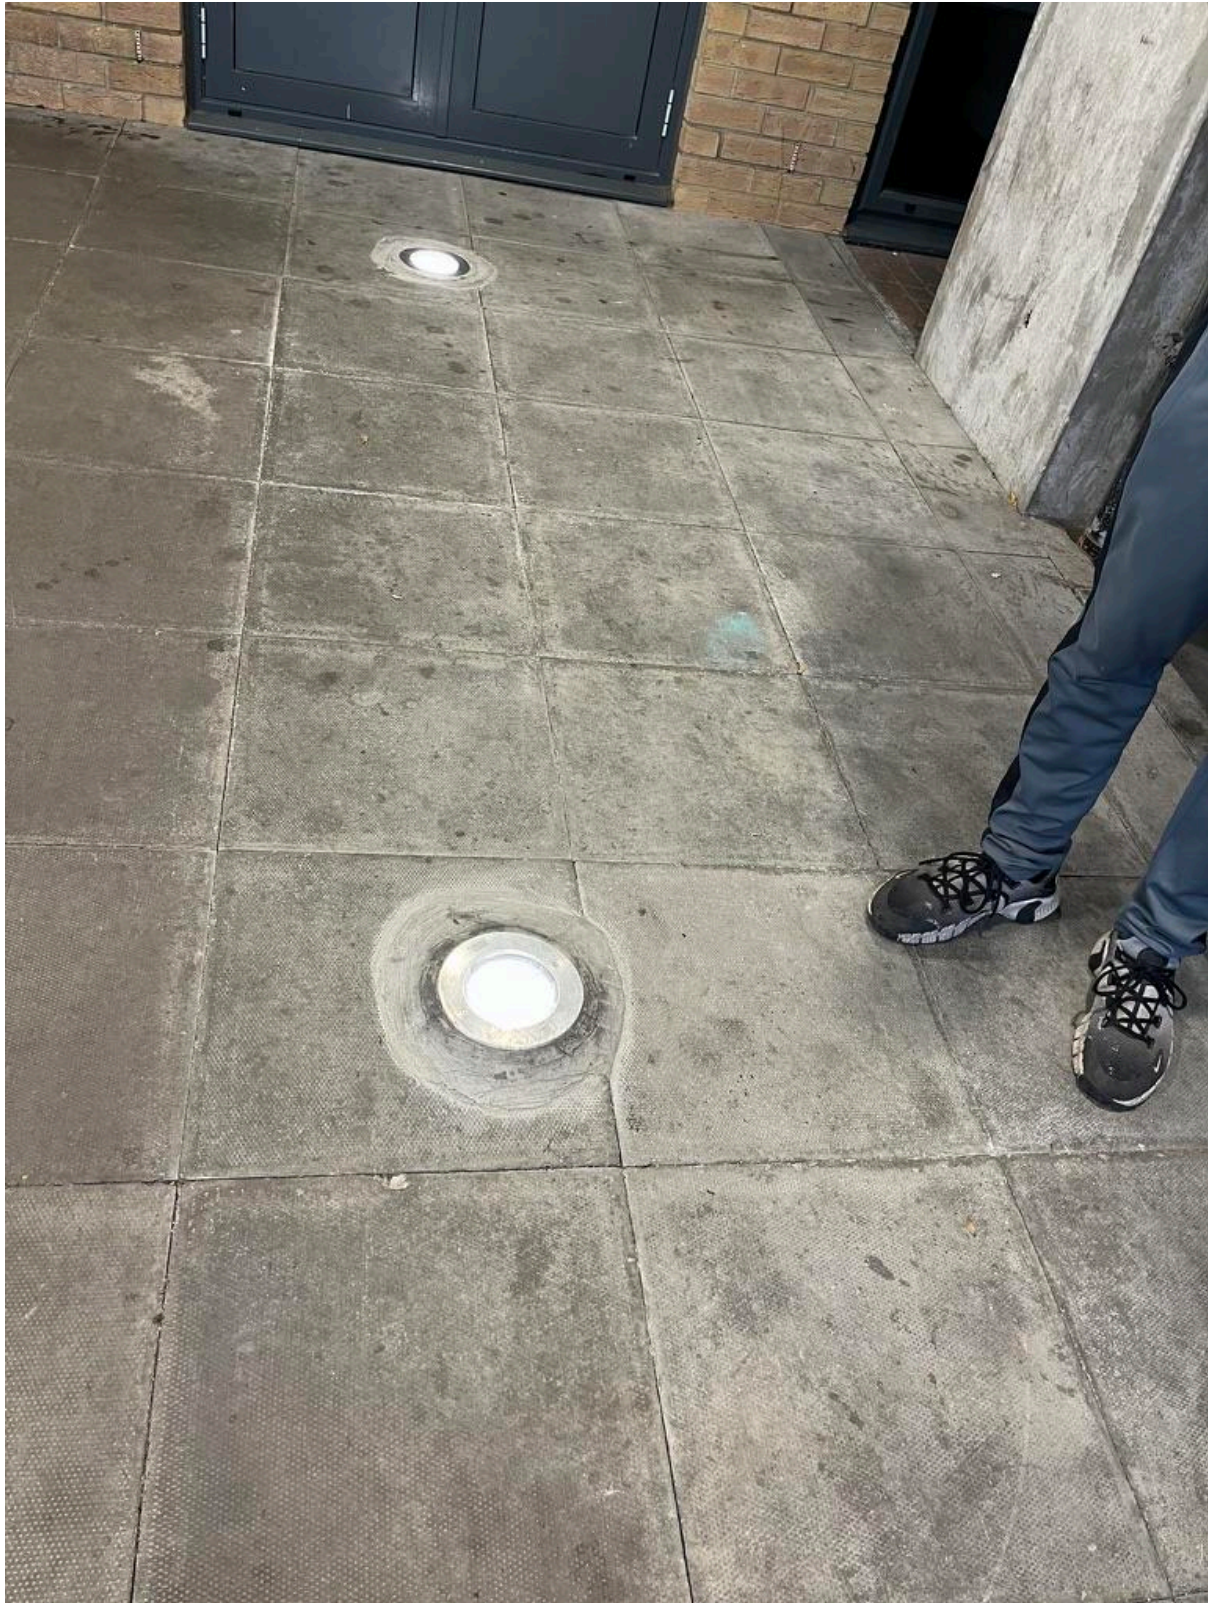
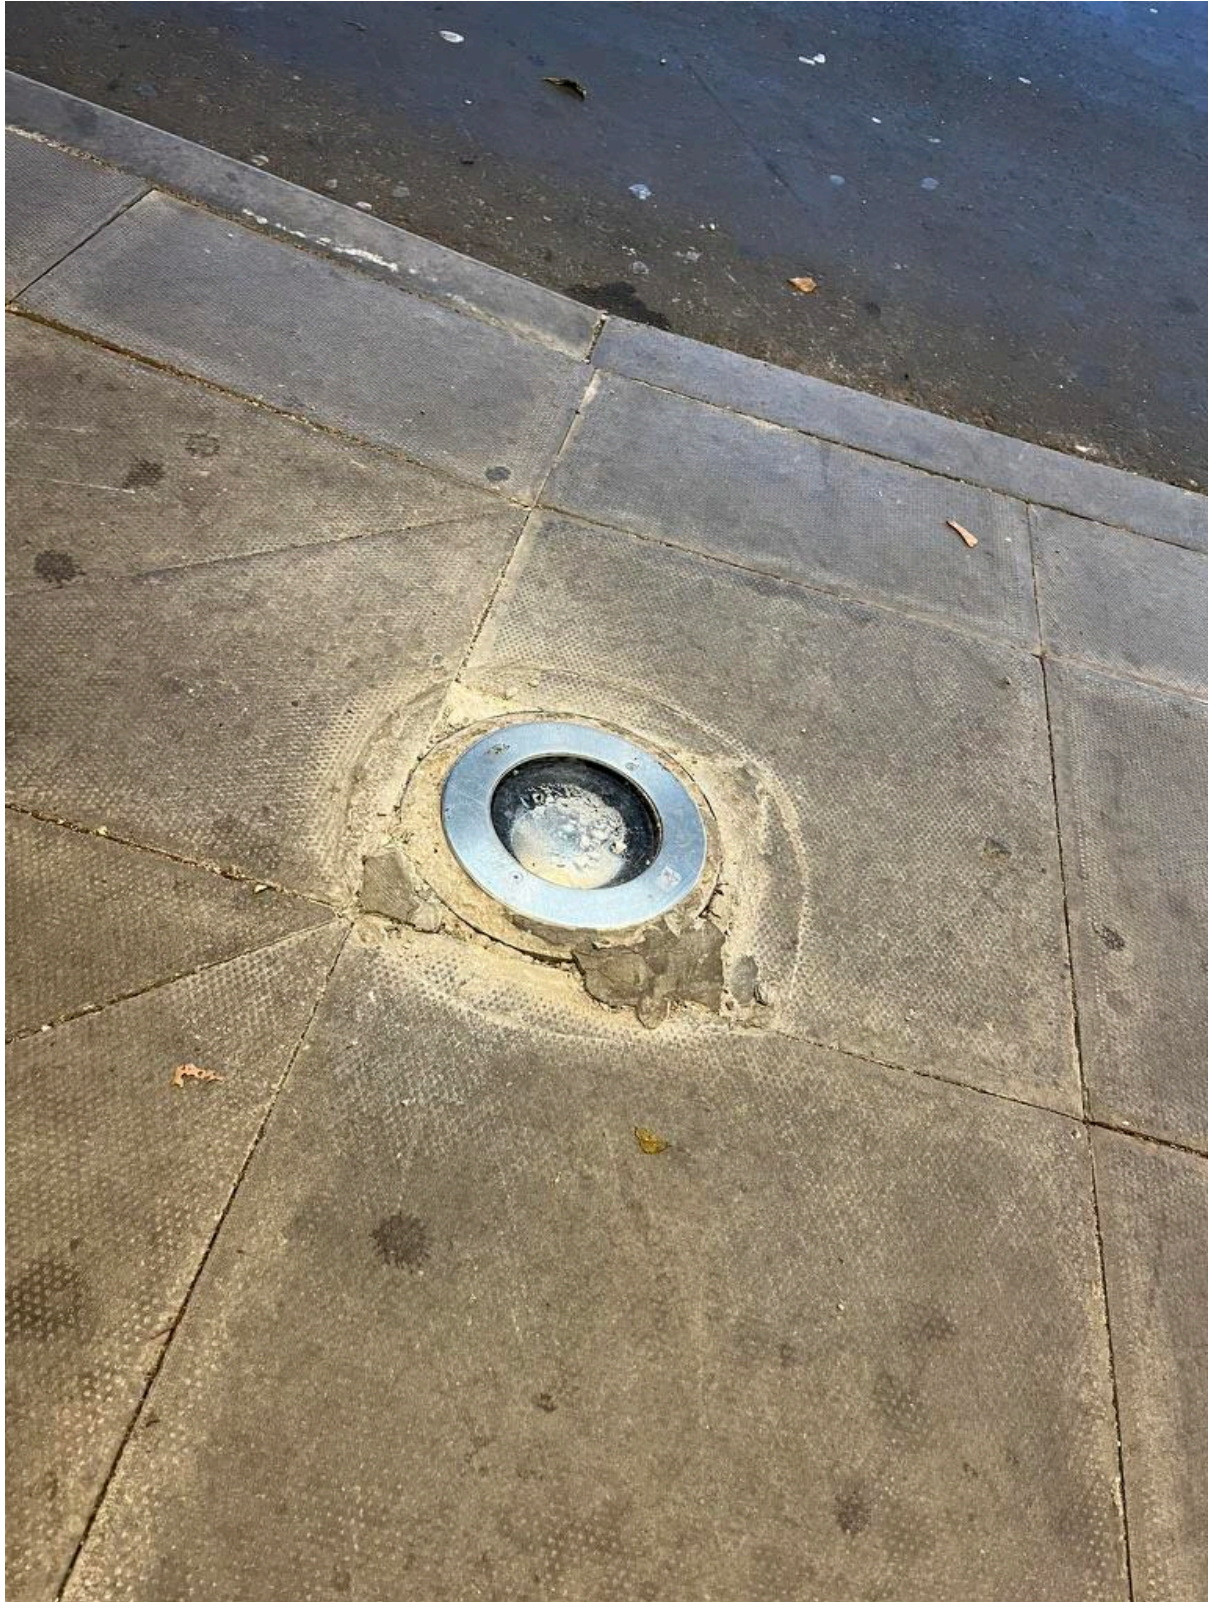
- The survey carried out for this report has identified the newly installed lights as being installed so that the bezels sit too high above the paving level forming a trip hazard. One of the lights also showed evidence of water penetration though this may now have been replaced.

1. The entrance to Block B is in a car park undercroft. The floor is finished with concrete paving slabs and the lights are recessed into this. It is not known what is under the slabs.
2. The lights have been fixed in such a way that the bezels form a lip which is a trip hazard. The marks left on the slabs, presumably by the previous lights, are unsightly and should have been cleaned as are the areas of cement infill.

- Long leaseholders will have been charged for the lighting installation and they should not be charged for remedial works.
